## **Gilding technique in Islamic monumental decorated ceilings in Cairo: analytical study.**

**Atef A. Brania**

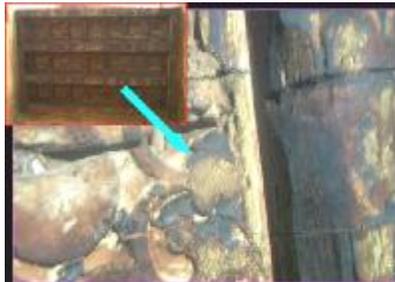
Fig. 3 Photographs (macro and micro) corresponding to the gilded ceiling of Khankah and mausoleum of sultan Beybars El-Jashankir shows its status.

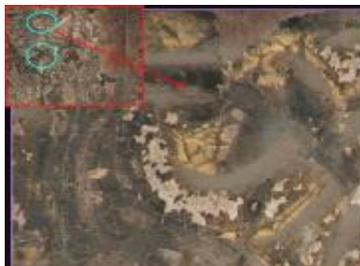
Fig.5 Photographs corresponding to the gilded decoration of Madrasa of Krasnker Elmansory shows its status.

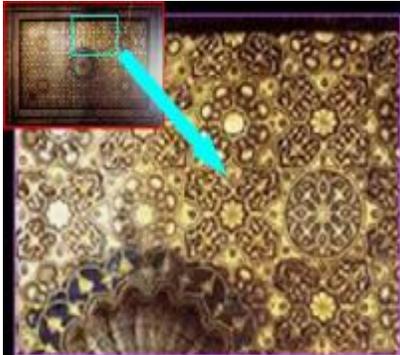
Fig. 6 Photographs (macro and micro) Shows details from fig.3 decoration of the (notice the severe damage of the gilded decoration).

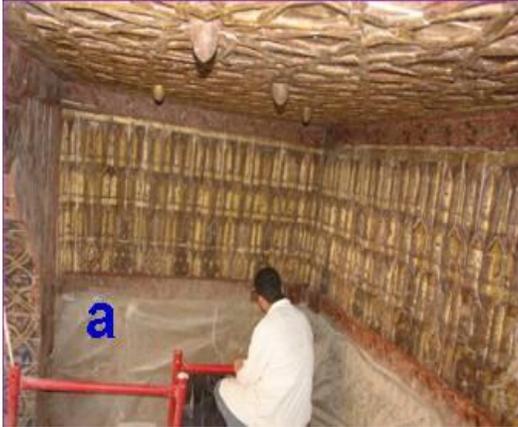
Fig. 11 a,b Photographs (macro and micro) corresponding to the gilded ceiling of El-Sadat house shows its status.( Notice the gilding craquelure).

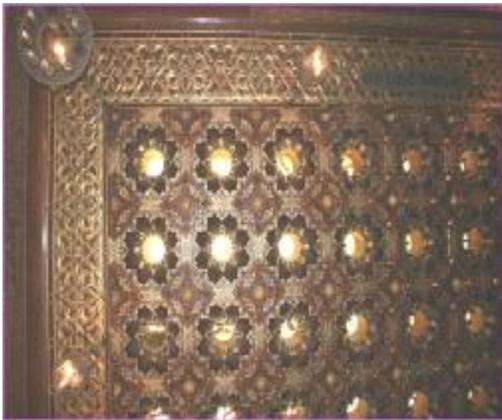
Fig. 12 Photograph corresponding to the original gilded decoration of the ceiling of mosque of the palace of prince Mohamed Ali shows its status.

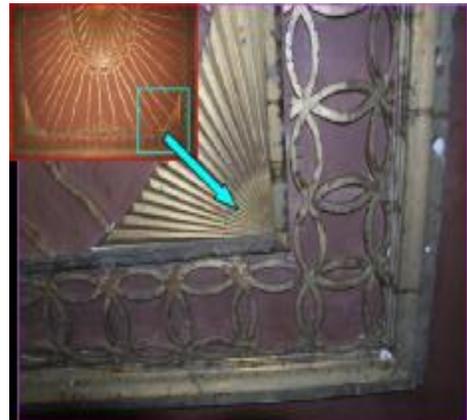
Fig. 13 Photographs (macro and micro) corresponding to the ceiling extension of mosque of palace of prince Mohamed Ali (previous gilding intervention) shows the severe damage.

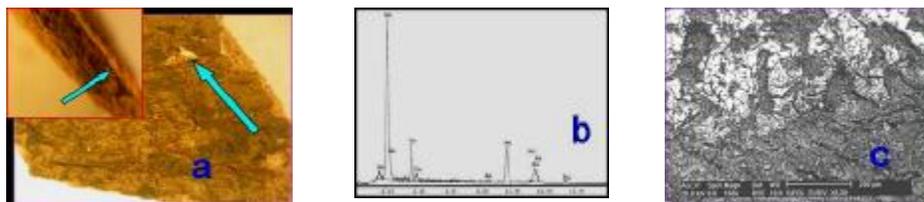
Fig. 14 Gilded sample from Madrasa of El-Nasser Mohamed Ibn Qaloon: a) Microphotography and cross-section corresponding to the sample showing the layers described: top yellow-gold layer (very deteriorated gilded , an extensive net of 'craquelure', producing small plates); b) EDX analysis in surface layer of the sample shows its components; c) SEM micrograph of the sample (surface deterioration very well

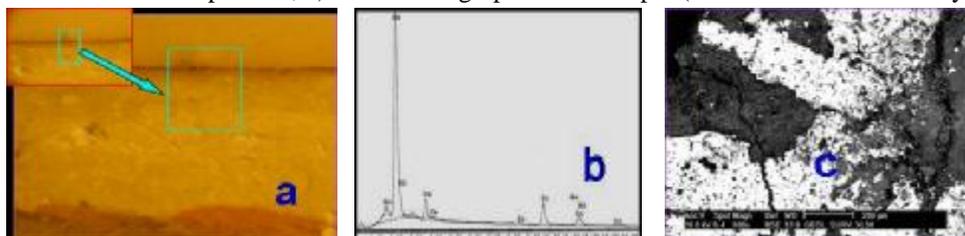
Fig. 15 Gilded sample from Khankah and mausoleum of sultan Beybars El-Jashankir: a) Microphotography corresponding to the sample (deteriorated gilded, applied on bole); b) EDX analysis in surface layer of the sample shows its components; c) SEM micrograph of the sample (surface deterioration observed).

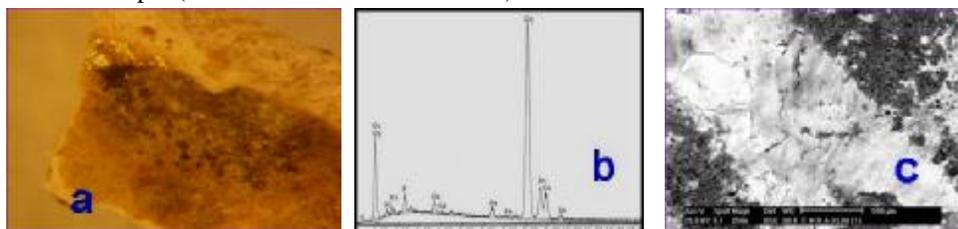
Fig. 16 Gilded sample (previous intervention) from Khankah and mausoleum of sultan Beybars El-Jashankir: a) Microphotography corresponding to the sample (deteriorated gilded); b) EDX analysis in surface layer of the sample shows its components; c) SEM micrograph of the sample (surface deterioration observed).

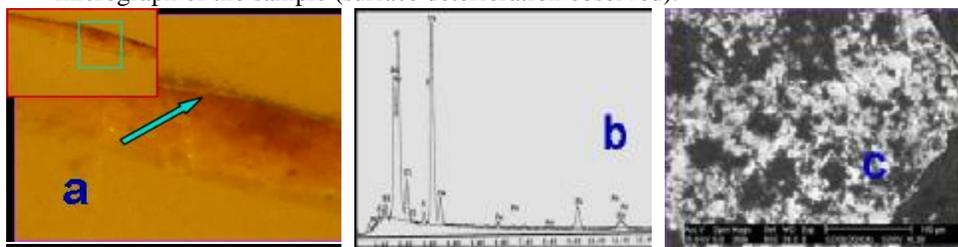
the nature of the organic medium was very difficult. The result of FTIR analyses, were compared with reference spectra, with well known organic adhesives, indicating to the size is a deteriorated protein base (indicating to glue). The glue was used as a mordant for the water gilding leaves and the chalk plus some of gypsum was so clear in the gilding samples representing the preparation layer and the surface accumulations (fig.17).

Fig. 17 Gilded sample from Mosque of Shraf El-Dien.: a) Microphotography corresponding to the sample showing the layers described: top yellow-gold layer (very deteriorated gilded); b) EDX analysis in surface layer of the sample shows its components; c) SEM micrograph of the sample (surface deterioration observed).

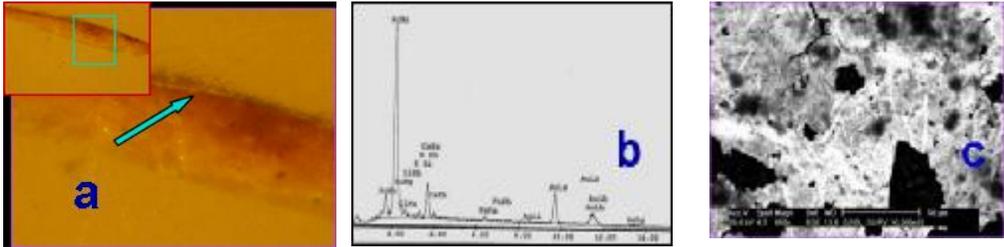
Fig. 18 Gilded sample from Madrasa of Krasonker Elmansory: a) Microphotography of cross-section corresponding to the sample showing the layers described: top yellow-gold layer (very deteriorated gilded); b) EDX analysis in surface layer of the sample shows its components; c) SEM micrograph of the sample (missing and deterioration observed).

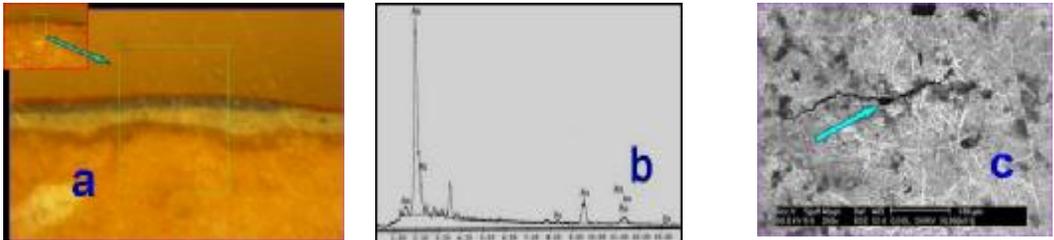
Fig. 19 Gilded sample from Madrasa of El-Zaher Brqoq: a) Microphotography of cross-section corresponding to the sample, the four preparation layers are so clear, bole is the third followed by gilding; b) EDX analysis in surface layer of the sample shows its components; c) SEM micrograph of the sample (surface deterioration observed).

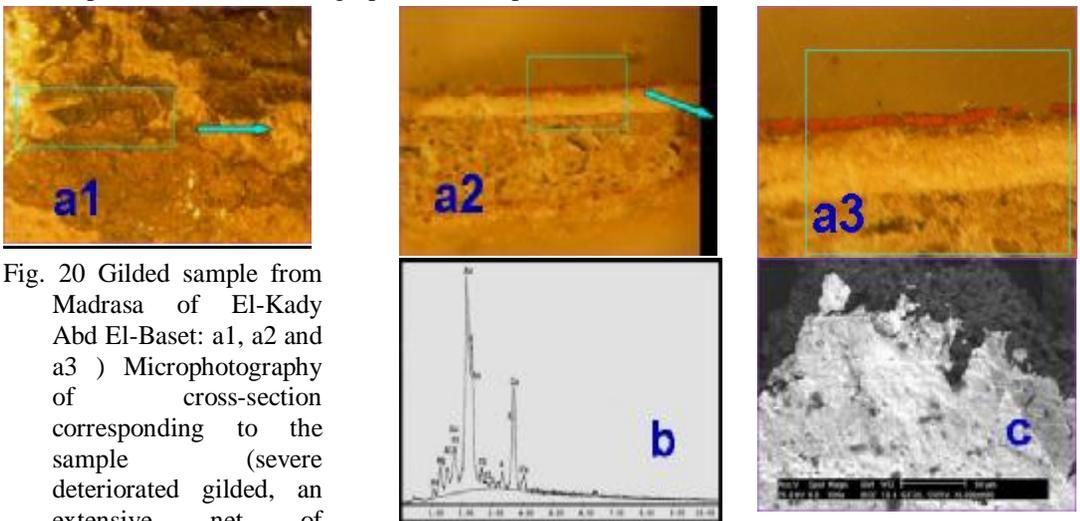
Fig. 20 Gilded sample from Madrasa of El-Kady Abd El-Baset: a1, a2 and a3 ) Microphotography of cross-section corresponding to the sample (severe deteriorated gilded, an extensive net of 'craquelure', producing small plates) , the red preparation bole layer is so clear; b) EDX analysis in surface layer of the sample shows its

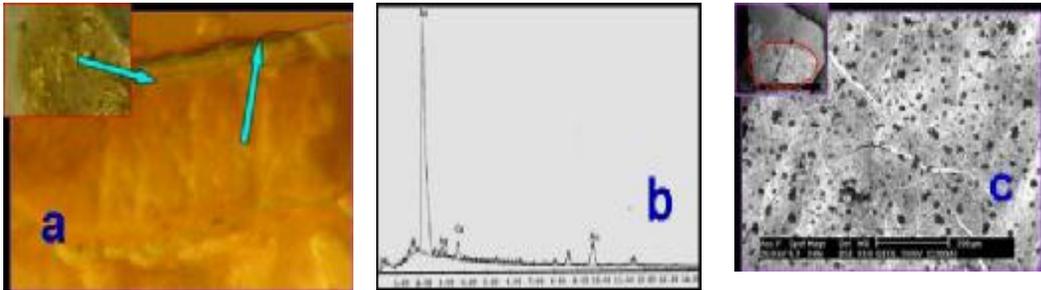
Fig. 21 Gilded sample from Mosque of El-Kady Yehia Zein El-Dine: a) Microphotography and cross-section corresponding to the sample (deteriorated gilded); b) EDX analysis in surface layer of the sample shows its components; c) SEM micrograph of the

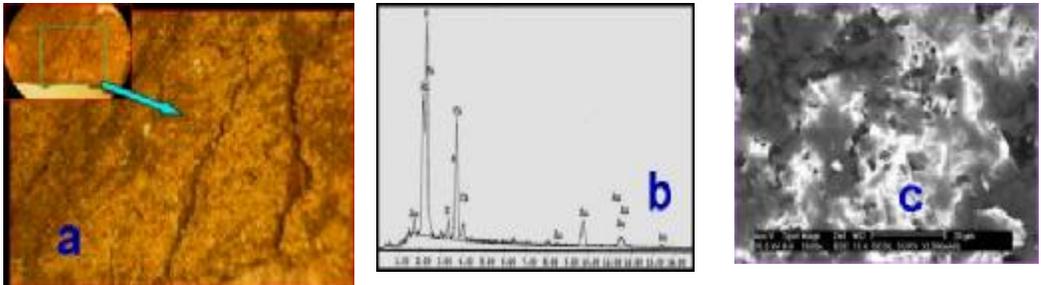
Fig. 22 Gilded sample from Mosque of Moheb El- Dine Abo El-tayb: a) Microphotography corresponding to the sample (deteriorated gilded, an extensive net of 'craquelure', producing small plates); b) EDX analysis in surface layer of the sample shows its components; c) SEM micrograph of the sample (surface deterioration observed).

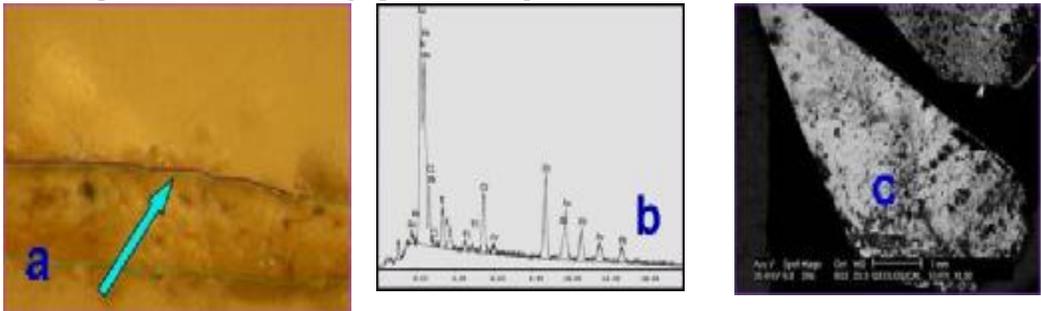
Fig. 23 Gilded sample from El-Sadat house: a) Microphotography of cross-section corresponding to the sample (deteriorated gilded); b) EDX analysis in surface layer of the sample shows its components; c) SEM micrograph of the sample (surface deterioration observed).

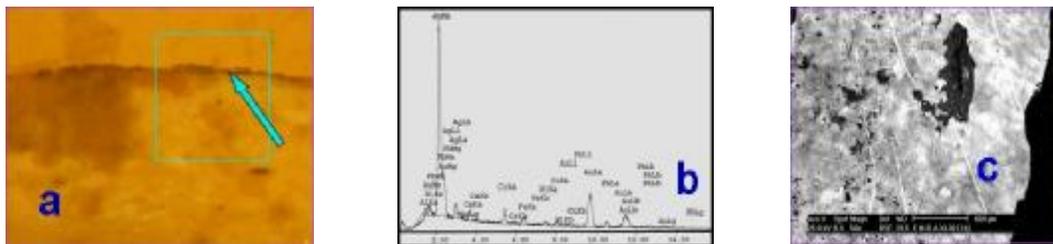
Fig. 24 Gilded sample from palace of prince Mohamed Ali: a) Microphotography of cross-section corresponding to the sample (deteriorated gilded); b) EDX analysis in surface layer of the sample shows its components; c) SEM micrograph of the sample (surface deterioration observed)

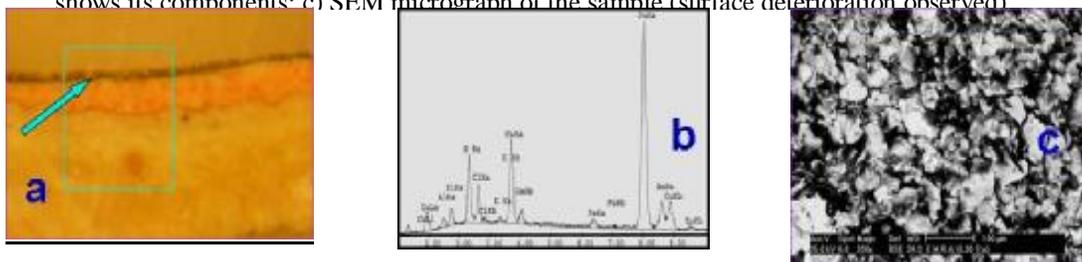
Fig. 25 Gilded sample (intervention) from palace of prince Mohamed Ali: a) Microphotography of cross-section corresponding to the sample (new intervention applied on bole); b) EDX analysis in surface layer of the sample shows its components, brass Cu,Zn,; c) SEM micrograph of the

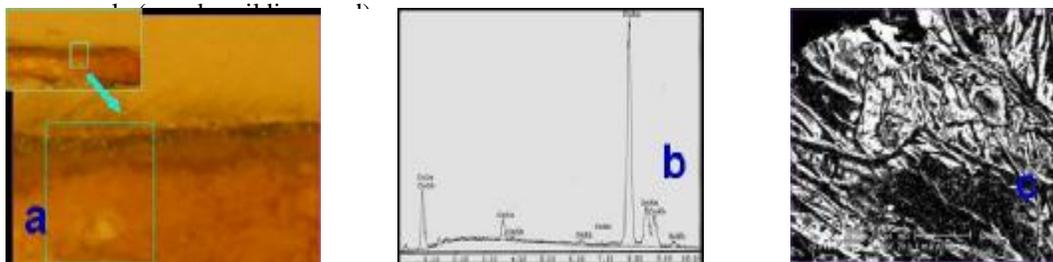
Fig. 26 Gilded sample (previous intervention) from mosque of Palace of prince Mohamed Ali: a) Microphotography of cross-section corresponding to the sample (deteriorated gilded); b) EDX analysis in surface layer of the sample shows its components; c) SEM micrograph of the sample (gold leaves in bad application observed).
