Characterization of the Mamluk painting materials in Cairo, Egypt: El-Ashraf Bersbay Madrasa (826 A.H/ 1423 A.D) a case study.

Madrasa of sultan Al-Ashraf Bersbay (826 H/1423A.D.)

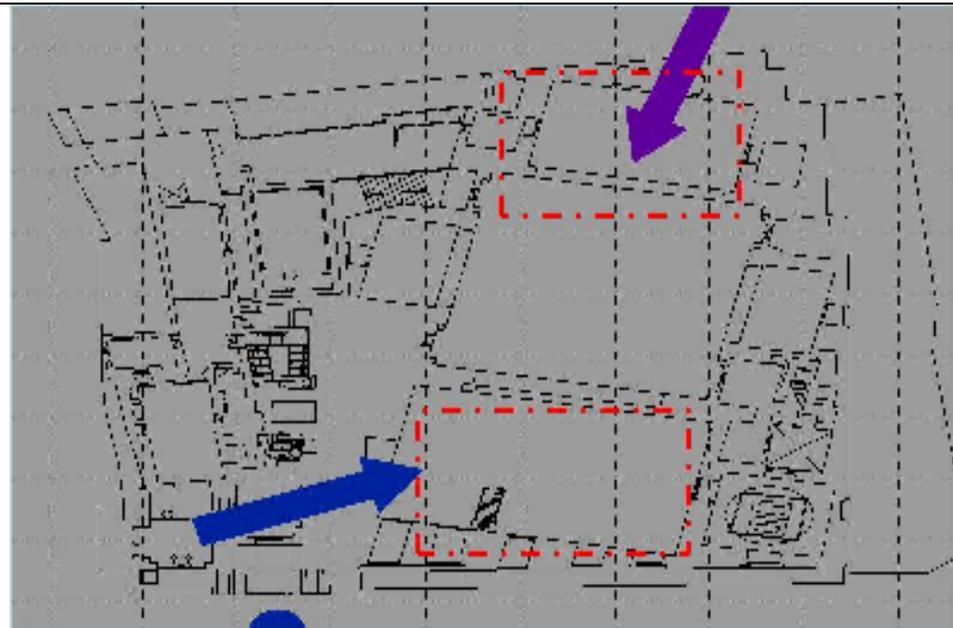
Fig.2 shows plan Al- Ashraf Bersbay Madrasa ,” notice the main two iwans “.

The main *iwana* of the *qiblah* is distinctively larger in size (16.5 by 12.8 meters) and has a wooden ceiling, which is decorated with a beautiful paintings consisting of floral and geometric elements. The *iwana* overlooks the school courtyard through a large horse-shoe arch. The opposite *iwana* is smaller in size (11.2 by 8 meters) and has a wooden ceiling that dates back to the foundation of the school. It includes some gilded geometric ornaments and a large niche flanked by two smaller ones. The northern and the southern sides of the school have two smaller *iwans*.³

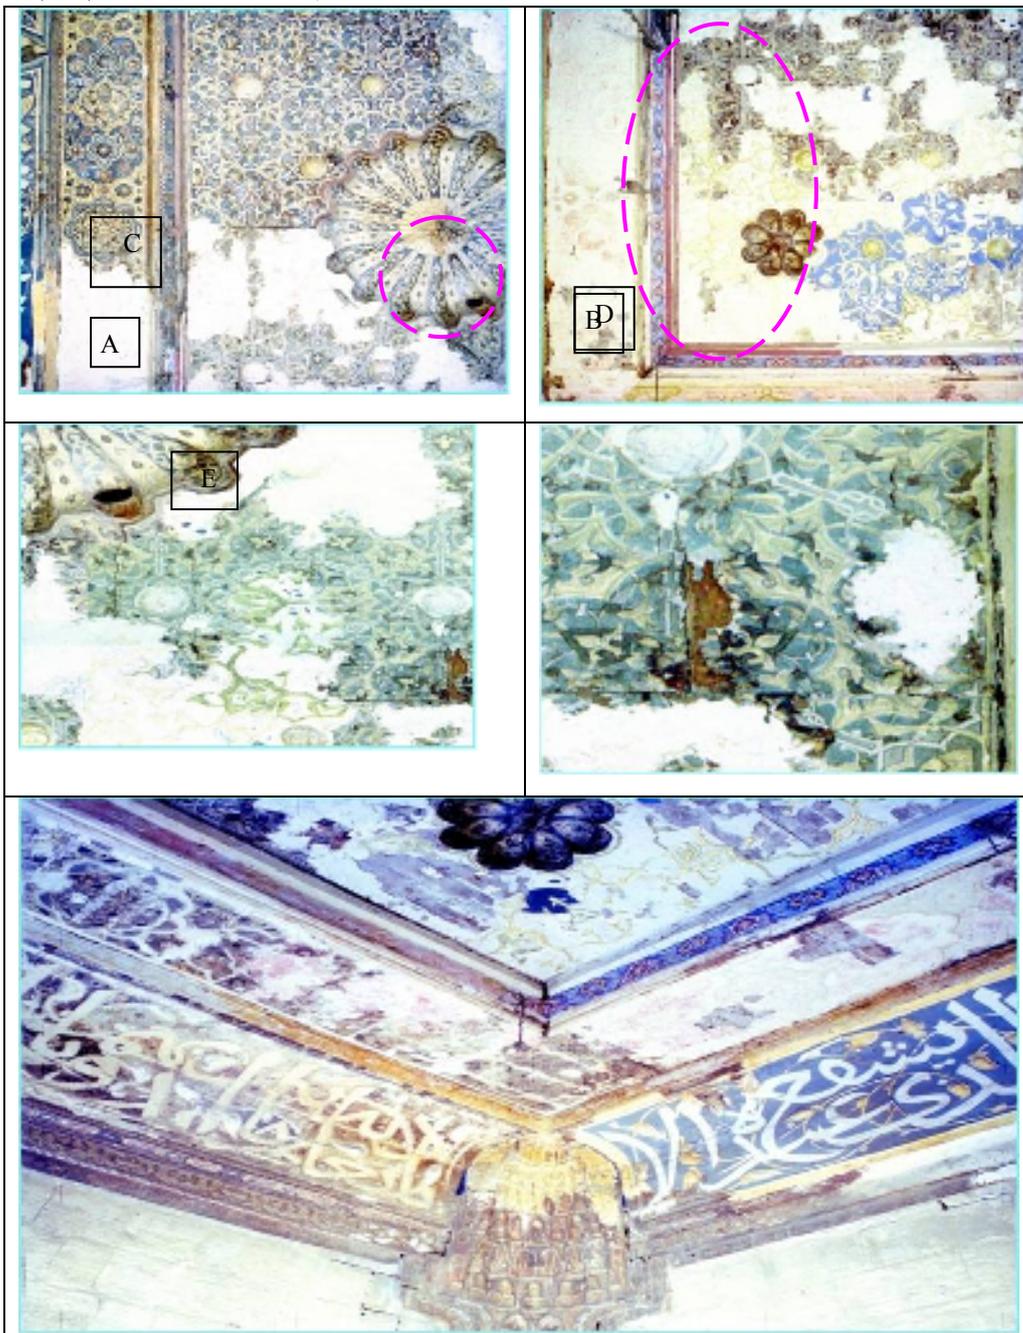
Fig. 5 A- E. Shows details from the AQC., decoration of Al- Ashraf Bersbay Madrasa, “notice the previous intervention and the very bad need of restoration “.

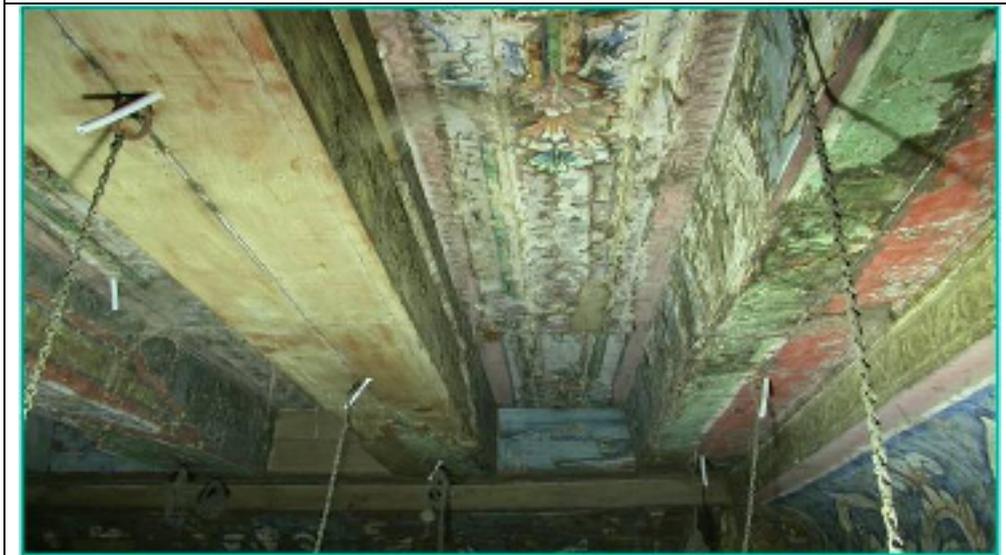
Fig. 7 A- D Shows the QC, decoration of Al Ashraf- Bersbay Madrasa, “notice the severe deterioration “.

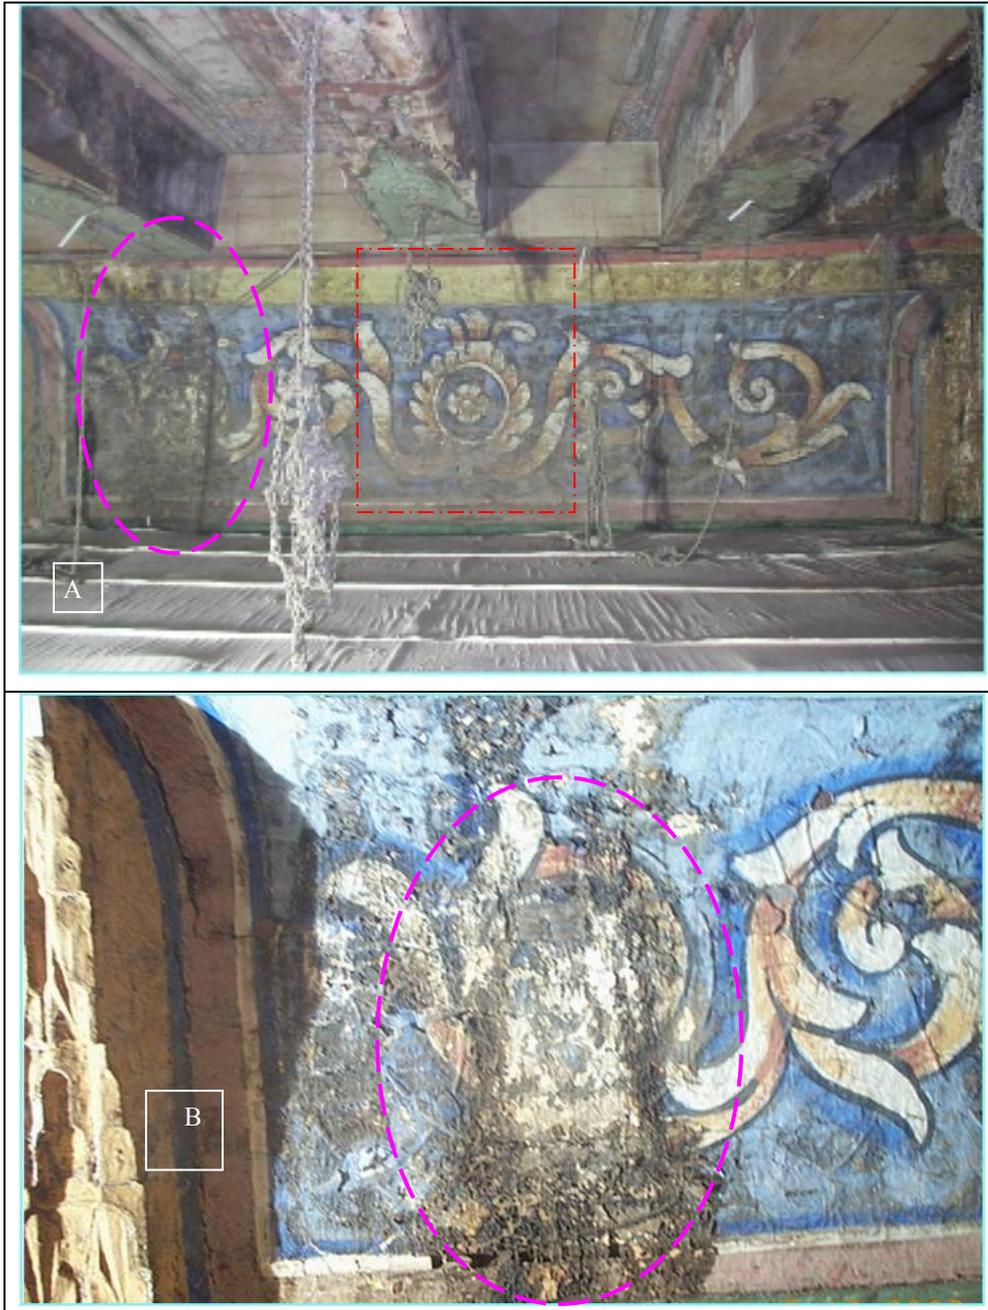
Fig.8 A, B., Shows, details from the Q.C. decoration of Al Ashraf Bersbay Madrasa and its very bad status.

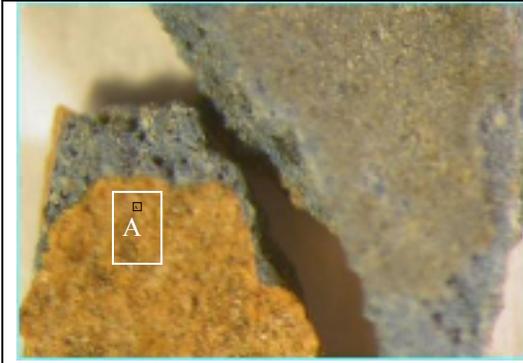
Fig.27- LOM photomicrograph shows deteriorated blue pigment with painting ground, X220, AQC.
