Two Examples of Egyptian Alabaster Weathering, Deterioration and Damage from Ancient Egyptian Buildings and Islamic Buildings in Egypt and Some Recommendations of Preservation.

Abdou El-Derby

Abstract:

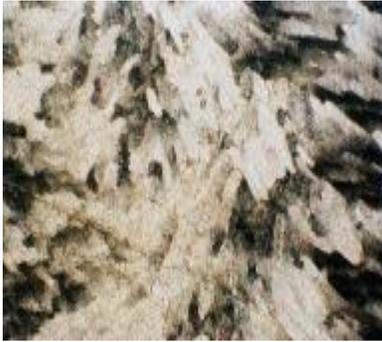
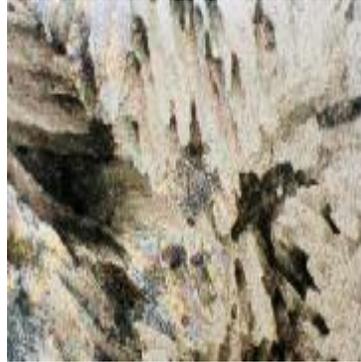
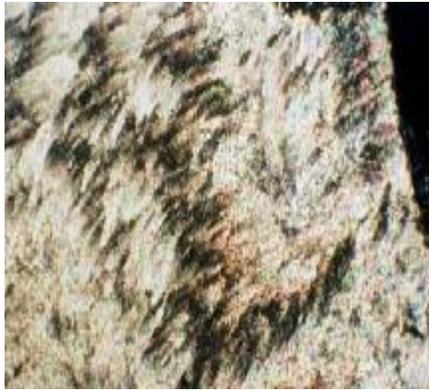
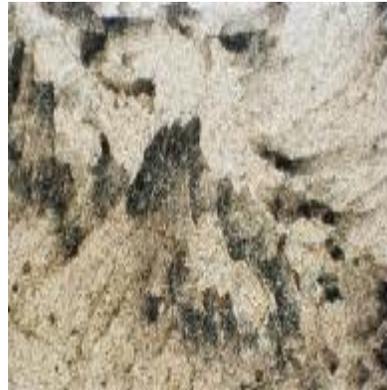
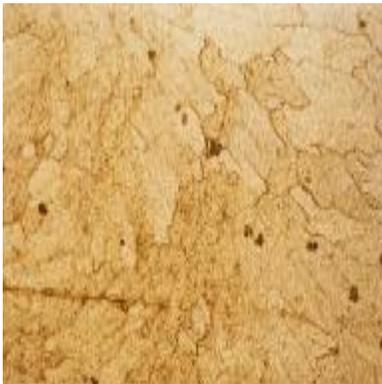
Figs. 1-5 Thin sections microphotograph of a an alabaster sample of Wadi El Assiuty the source of alabaster at Karnak displays drusy mosaic of calcite (disoriented small calcite crystals), the texture is an harmonic mixture of fibrous and equant mosaics resulting in the fine layering of the alabaster a variety of bands of variety of translucency degrees especially delicately banded which due to alternation of bands of translucent creamish type with the opaque milky white type , a yellowish translucent band consists of elongated fibrous crystals , the texture is a fibrous mosaic alternating with an equant mosaic , abundant amorphous carbonate either as patches or as bifurcating vein lets , and there is an important note : there no almost micro cracks or fissures with presence of some gypsum crystals comparing with the weathered samples were taken from Karnak according to explain forth coming .

And there is an important note : there no almost micro cracks or fissures with presence of some gypsum crystals comparing with the weathered samples were taken from Karnak according to explain forth coming (figs.).

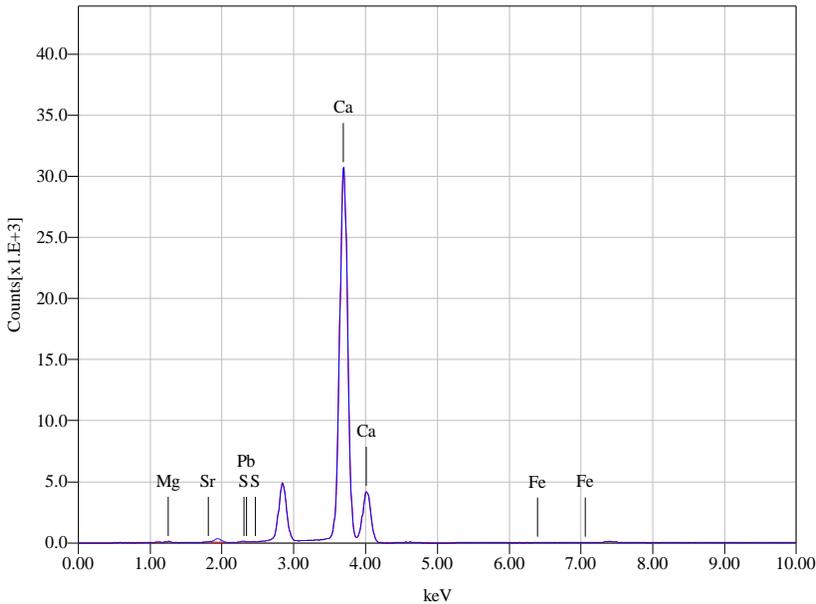
Fig. 7 X-ray fluorescence patterns of part of an alabaster sample of Wadi El Assiuty the source of alabaster at Karnak displays presence of calcium as a principle element in addition to magnesium , strontium

X-ray diffraction and fluorescence analysis patterns of a an alabaster sample of Wadi El Assiuty the source of alabaster at Karnak displays presence the calcite CaCO_3 as the principle mineral component , the secondary materials are composed mainly of calcite, in addition to presence of some gypsum crystals and also is found contains - chemically -calcium as a principle element in addition to minute traces of elements of magnesium , strontium (figs 1-7.).

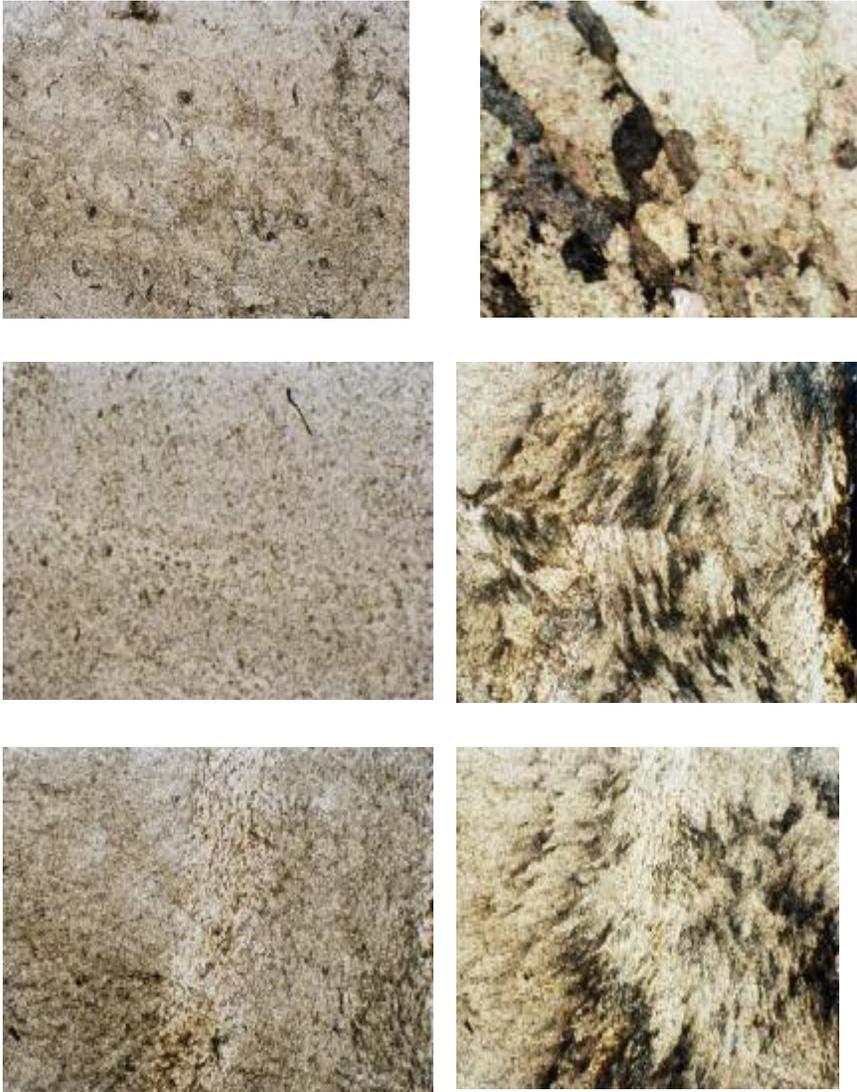
Figs. 8-13 Thin sections microphotograph of a translucent alabaster sample of Wadi Sannur the source of alabaster at Muhammad Ali Mosque (Normal – left column) (C.N - displays a mosaic of interlocked calcite crystals of different size and shape.) right column They vary from flat platy to fibrous and bent, exhibiting undulatory extinction between crossed polarizers(right column) where he crystals have generally different optical orientations, zoning is also well-marked, representing the successive growth of different layers with the same optical orientation. In sections cut perpendicular to the elongation of the translucent crystals a mosaic of fibrous and fine patches of crystals appears, giving a characteristic wavy extinction between crossed polarizers (right column). Parallel orientation may be noted or just a random distribution of the feather-like crystals may be observed.

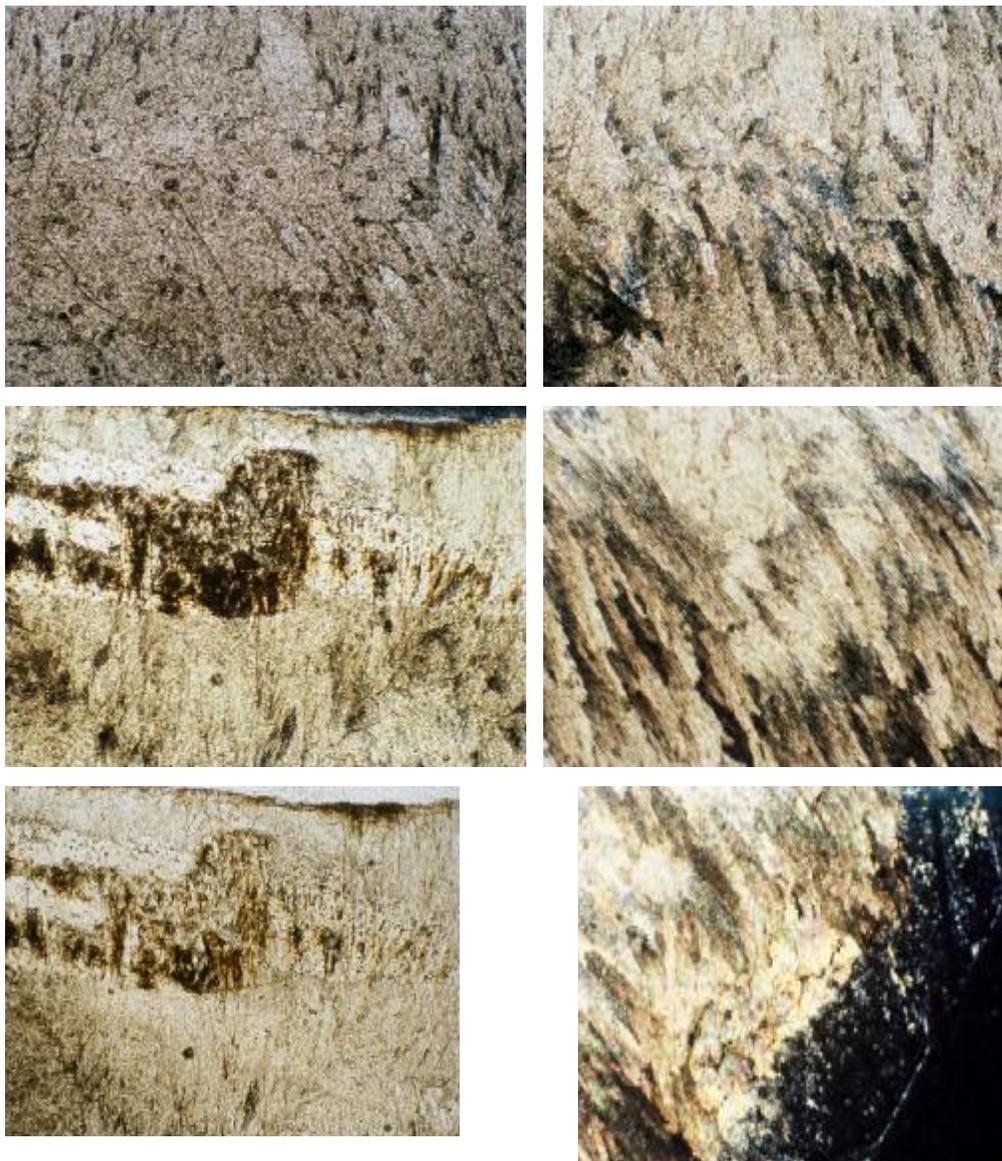
Figs. 14-19 thin sections microphotograph of a the milky-white bands alabaster sample of Wadi Sannur(Normal – left column) (C.N - right column) - Suturing may be distinct between groups of calcite bundles Contrary to the translucent bands- consist of an aphanic to finely grained (crystalline) mosaic of calcite. X-ray diffraction analysis of both the translucent and milky-white alabaster showed no aragonite lines. no gradation of growth has been observed between the milky-white and the translucent bands. In many cases the white bands appear to be fine and dense, giving a dark (opaque) appearance under the microscope. colloform texture is very common in these bands indicating their deposition from a colloidal medium.

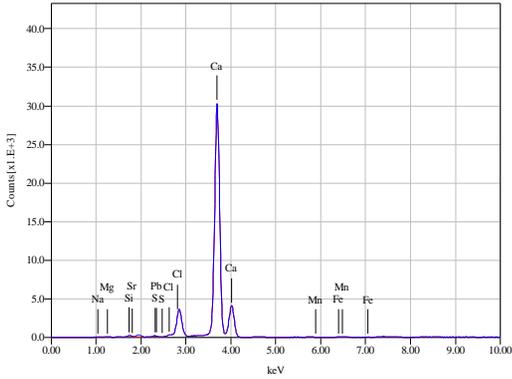
Figs . 20 -21 X-ray fluorescence patterns of part of a an alabaster sample of Wadi El Assiuty the source of alabaster at Sannur the source of alabaster at Muhammad Ali Mosque displays presence of calcium as a principle element in addition to magnesium and silicon .

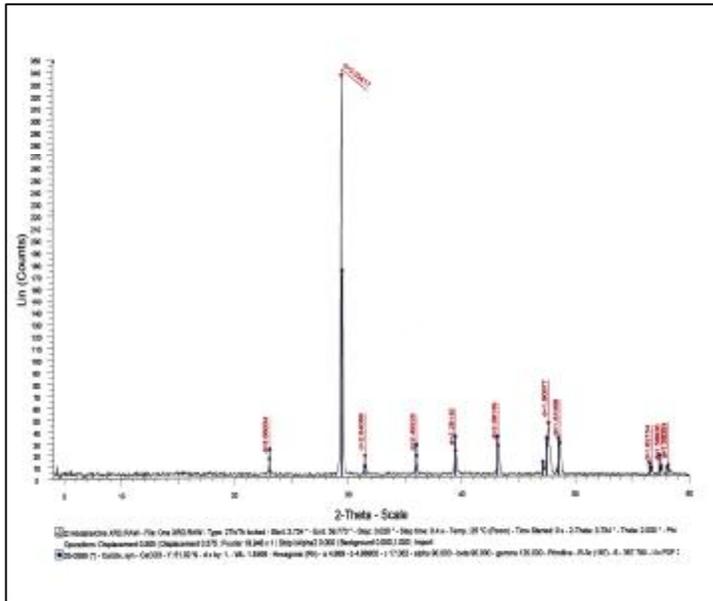
Figs. 22-23 X-ray diffraction analysis patterns of an alabaster sample of Wadi Sannur the source of alabaster at Muhammad Ali Mosque displays presence the calcite CaCO_3 as a main component .

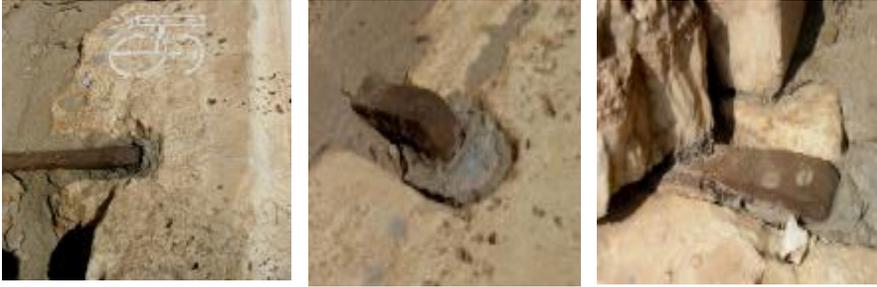
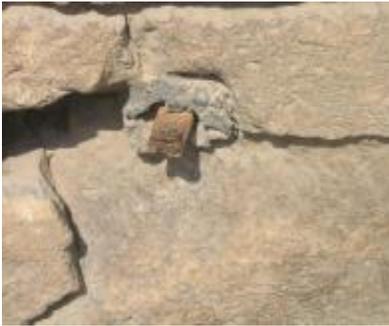
Figs. 24- 27 The short iron bars which were used to tie blocks of alabaster veneers to the wall core and were fixed in walls with lead , the rusting and corrosion of hundreds thousands of caused expansion consequently produced forces which in turn created tension resulting in the 1st type cracks , also I have to cite that the alabaster veneer were felled by their own dead overweight .

(these bars were fixed in walls with lead) - which produced forces which in turn created tension (figs. 24- 31) resulting in this type of crack which is less dangerous and have a local effect ⁽⁴⁴⁾ , but sometimes they located by accident in locations under excess load and are affected overstressing , in this case that type become dangerous ⁽⁴⁵⁾, also there is an important note that the alabaster veneers are thick to normal thickness of veneers and to be hanging on (its thicknesses range from twelve to twenty centimeters (the standard thickness about five centimeters) , the alabaster veneer slabs were felled sometimes by their own dead overweight , where its thickness range from 12-20 cm , so the weight of one square meter may reach to 500 kg.

⁽⁴⁴⁾ so they required local compensation by replacement the stone parts which were pushed outward with new parts , during these measures and repairs the rusted iron ties were noted and were removed as far as possible , see : Leliavsky , S., Reconstruction of Mosque of Mohamed Aly Pasha , Royal Egyptian institution of Engineers , No.123 , IMPR.MISR, S.A.E., Cairo, 1935, pp. 13-14.

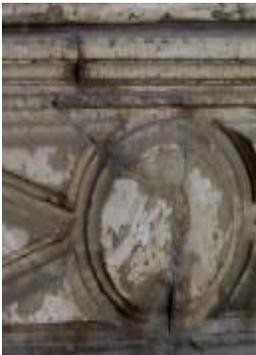
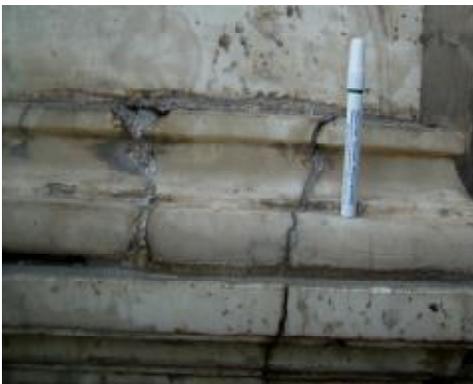
Figs. 28-31 the first type of cracks which are usually short and isolated involving small deformation of masonry , and they are distributed randomly and irregularly over the whole building - is related to both the physical and chemical properties of materials and constructional methods

There are two types of the numerous cracks which spread on the alabaster veneers of Muhammad Ali Mosque , the first type - which are usually short and isolated involving small deformation of masonry , and they are distributed randomly and irregularly over the whole building - is related to both the physical and chemical properties of materials and constructional methods , and isn't related to the stresses of the mechanical loads which the Mosque structure carries , these cracks were caused by the expansion - consequent on the rusting and corrosion of hundreds thousands of short iron bars which were used to tie blocks of alabaster veneers to the wall core

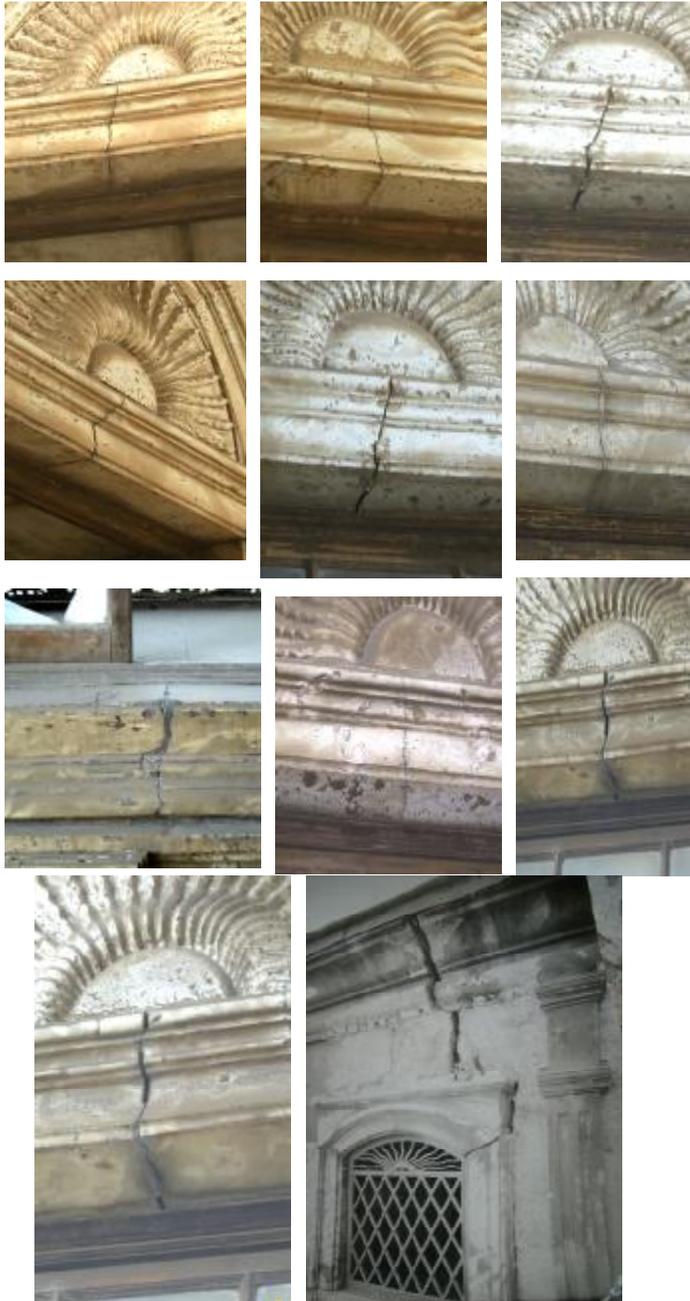
Figs. 32 - 42 Display cracks of 2nd type in the springings of all lintels above openings in the mosque at positions of heavy load, the lower left photo. From Supreme Council of Antiquities archives (1935) .

The second type of cracks occurred at positions of heavy load concentration which causes stress intensity which in turn transfer from part to part and from an element to other causing ceases in performance of duty particularly in elements which may never had been designed to carry or to resist these loads , so the effect of this type of cracks is not confined to its vicinity but its effect extends not only to other parts of the building but to the general equilibrium of it , such as the cracks at the springings of the four arches of the mosque may be because of the design of the metal tie-bars anchorage of makes it too weak to resist the stress imposed on them , or the volume of masonry engaged in transferring the thrust from the bars to the arches springings were too small to allow the stress being properly distributed , thereupon the stonework adjacent to the

bars was torn away from the rest of the masonry , the ties in turn lost their effectiveness , thus is considered the main cause of deformation of mosque (⁴⁶) .

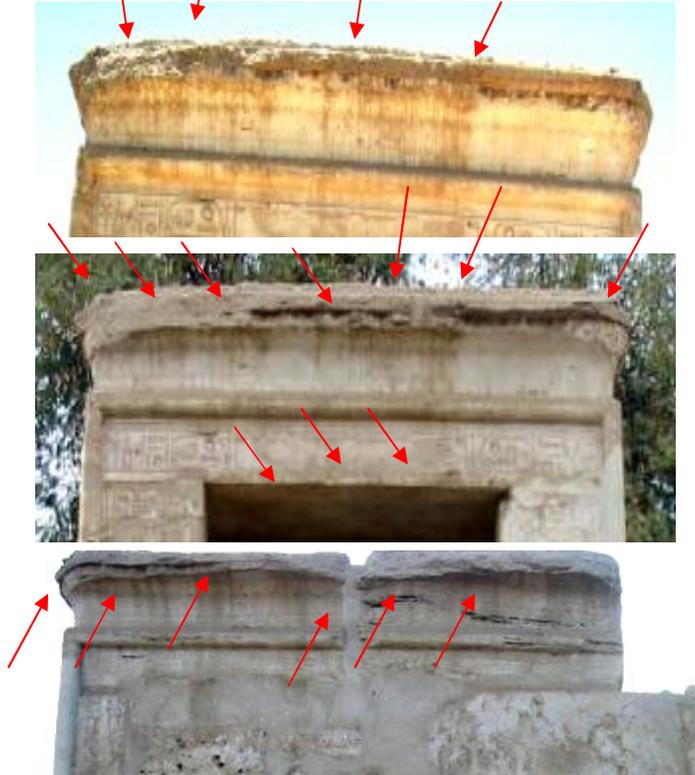
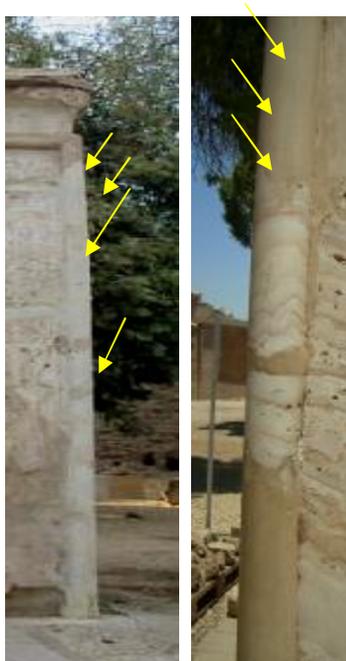
Figs. 43- 47 Display frailty and debility structure of some ornamental architectural elements of Egyptian alabaster chapels at Karnak such as the Cavetto Cornices and torie which are along the horizontal upper edge and along the corners of the façade of them , in addition to being hanged partially on space , have exposed them to fracture and loss or to erosion (arrows) .

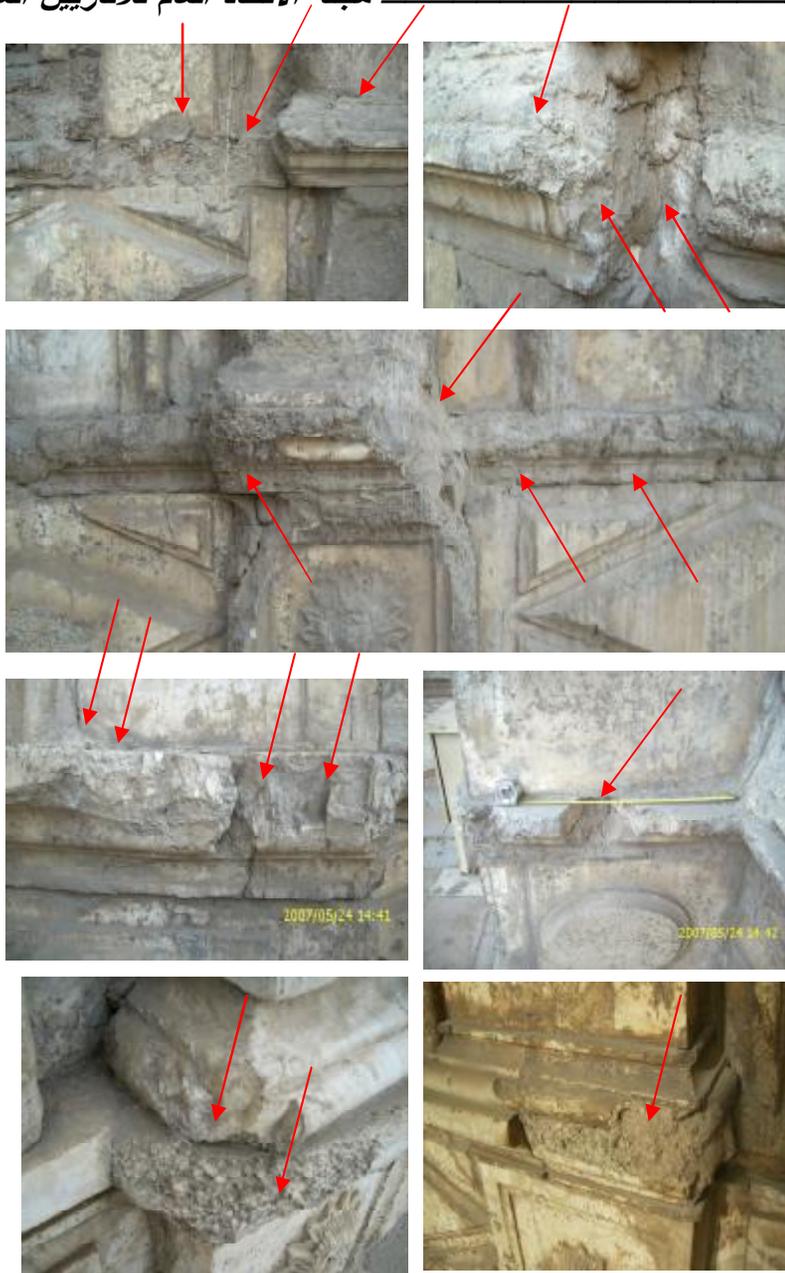
Fig.48-54 Frailty and debility structure of some ornamental architectural elements of Egyptian alabaster of Muhammad Ali Mosque such as the Cavetto Cornices , in addition to being hanged partially on space , have exposed them to fracture and loss or to erosion (arrows) , also disintegration and soiling can be noted .

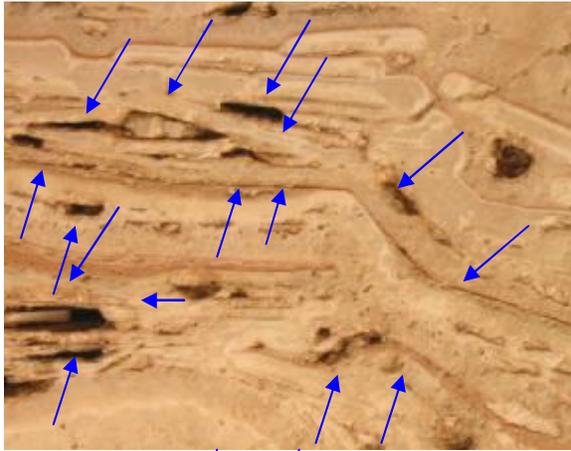
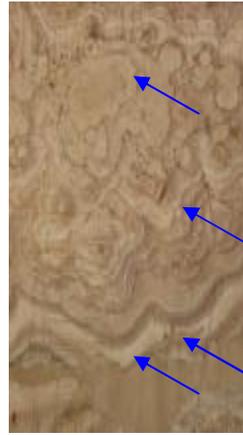
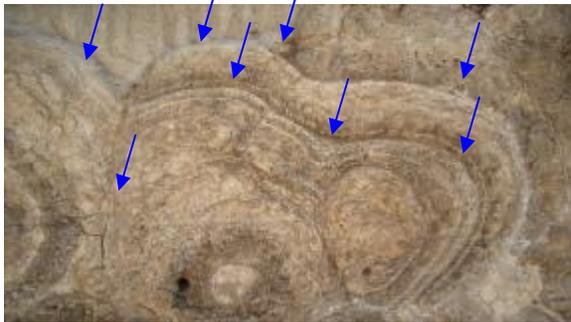
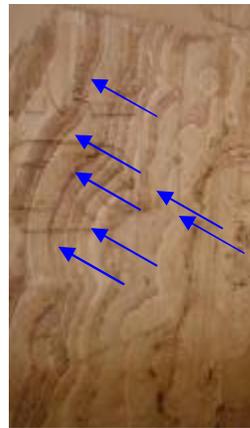
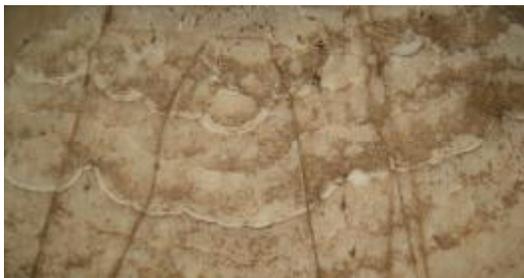
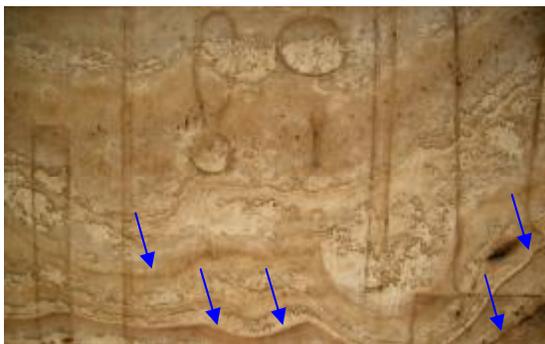
Figs. 55- 60 Display the Egyptian alabaster (Travertine) surfaces of chapels of Karnak of Wadi El-Assiuty characterized of presence of botryoidal or colloform structure and the planes of the colloform structure are weakness planes because of the tendency to break along these planes (arrows) , also display covering the convex and the outer surface of stone with a thin layer of red iron oxide and that indicts it belongs to The 3rd type of the colloform structure forms which is of colloidal origin and existence of the spheroidal surfaces - which due to surface tension phenomena

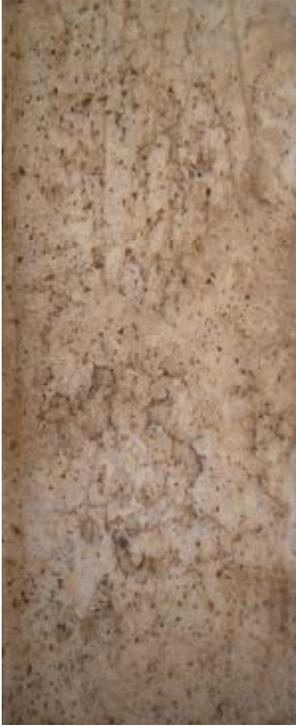
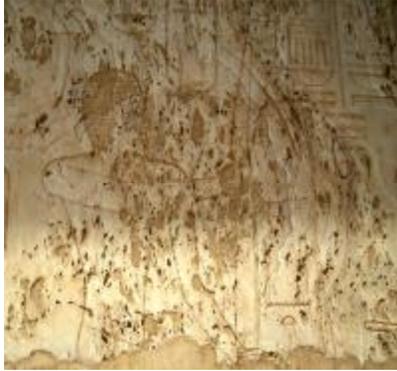
Figs 65-66 display the first type of vugs and open spaces is a minute cavities of distribution throughout the surfaces of the travertine of chapels at Karnak of Wadi El-Assiuty, and they were stained with red iron-oxide

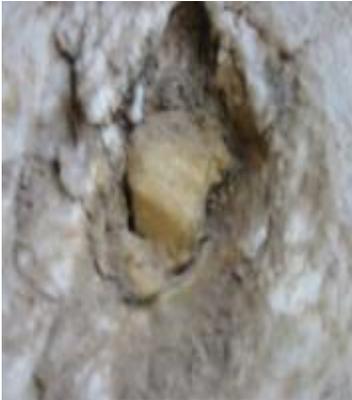
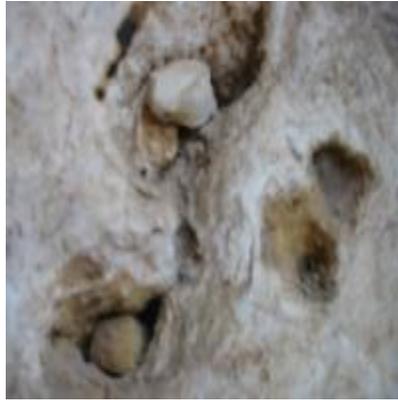
Figs 67-68 display the third type of vugs and open spaces is large 30-80 cm. long into which protrude almost spherical surface of the travertine of chapels at Karnak of Wadi El-Assiuty

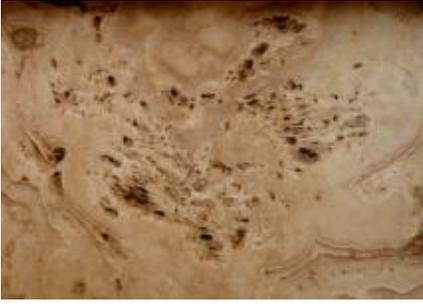
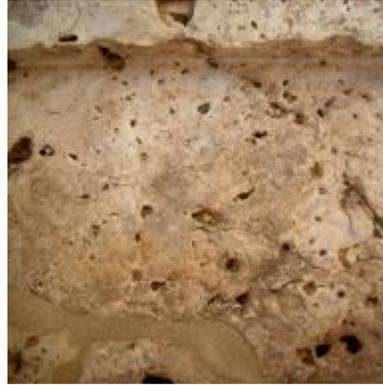
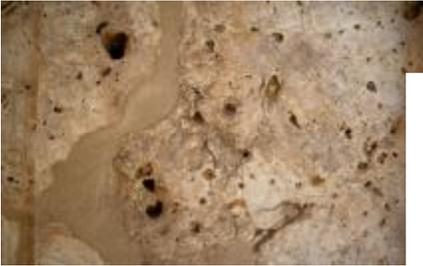
Figs 69 – 71 display the second type of vugs which is confined to parts which appear to the outer surfaces of the travertine of chapels at Karnak of Wadi El-Assiuty, of the alabaster deposit , the vugs occur elongated is of the milky white type

The second type of vugs which is confined to parts which appear to the outer surfaces of the travertine of chapels at Karnak of Wadi El-Assiuty, of the alabaster deposit , the vugs occur elongated is of the milky white type (figs.69- 72).

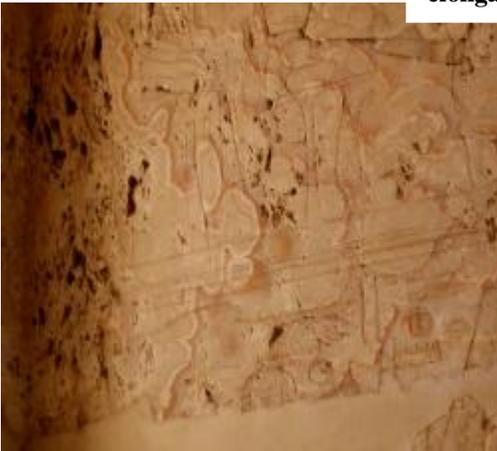
Fig. 72 display the vugs occur elongated is of the milky white type surfaces of the travertine of chapels at Karnak of Wadi El-Assiuty (it looks like weathering out of stone components clearing out of stone components

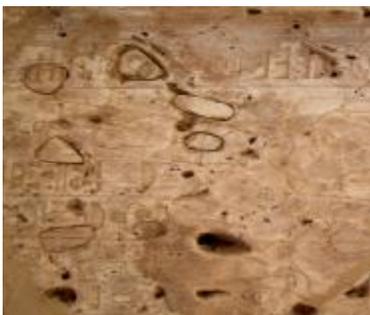
Fig.73 display the vugs repair in the surfaces of the travertine of chapels at Karnak of Wadi El-Assiuty

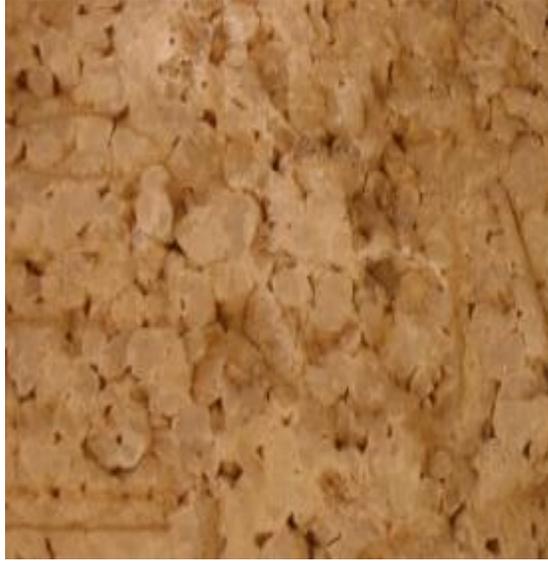
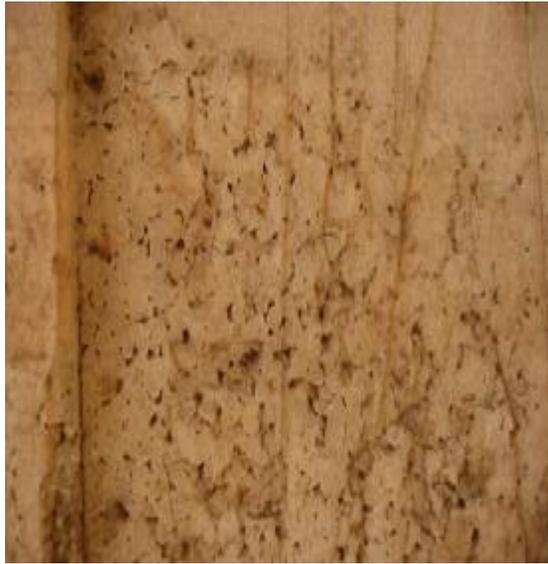
Figs. 74-75 Display superficial coarsening and granulation on the surfaces of the travertine of chapels at Karnak smoothed by corrosion polishing as external deterioration factors.

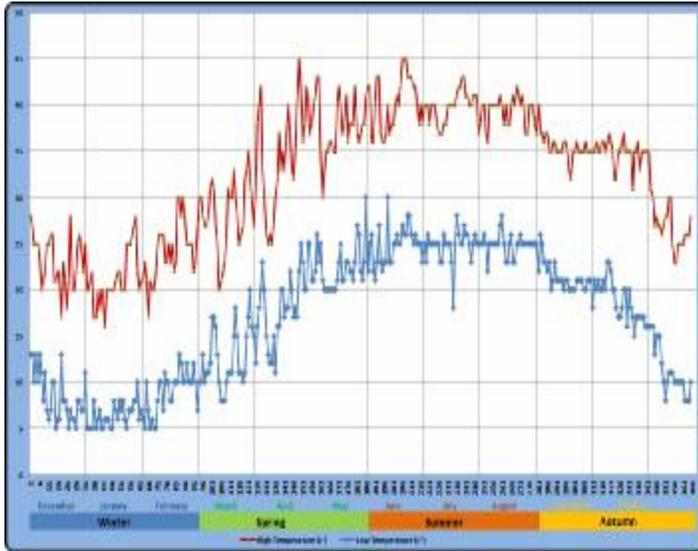
Fig. 76 display daily variation of air temperature in Luxor (maximum temperature and minimum temperature) during 2007

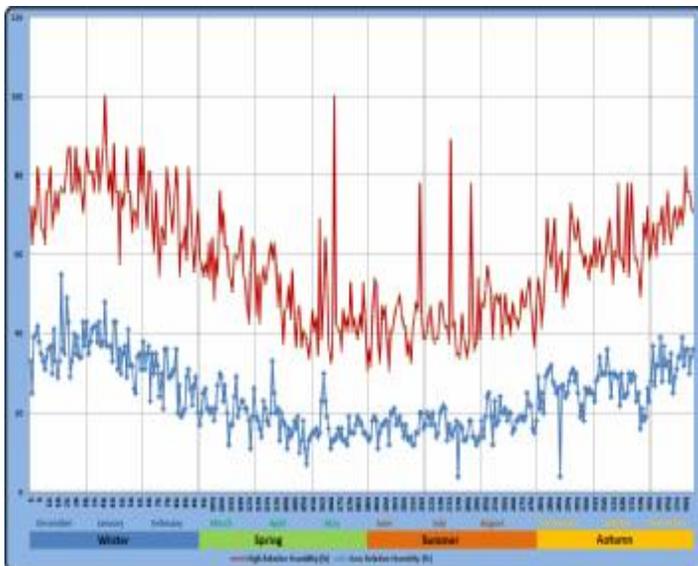
Fig. 77 display daily variation of relative humidity in Luxor (maximum temperature and minimum temperature) during 2007 .

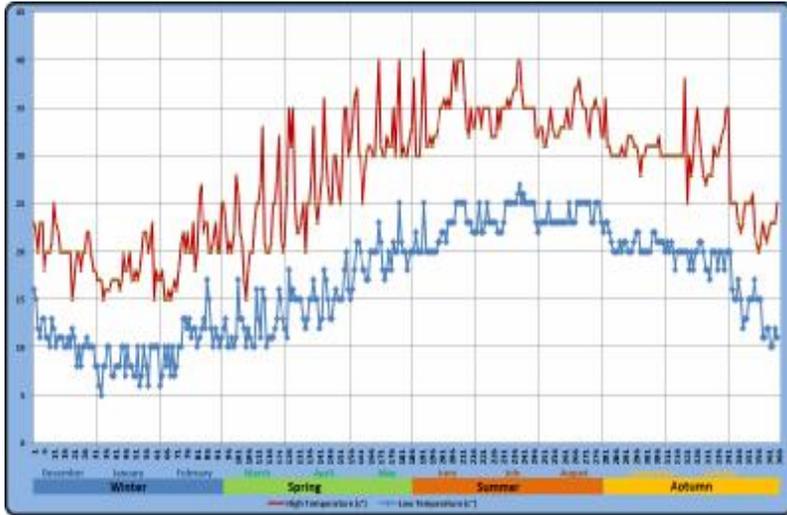
Fig. 78 display daily variation of air temperature in Cairo (maximum temperature and minimum temperature) during 2007 .

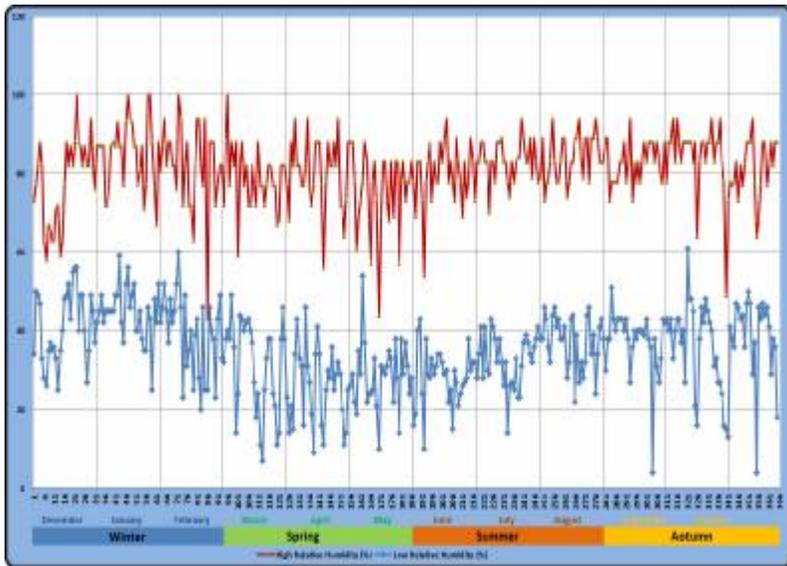
Fig. 79 display daily variation of relative humidity in Cairo (maximum temperature and minimum temperature) during 2007 .

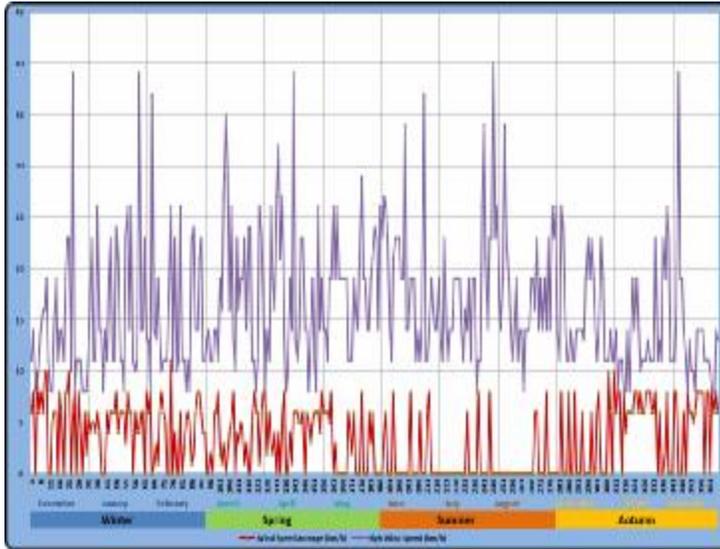
Fig. 80 display daily variation of wind speed in Luxor during 2007 .

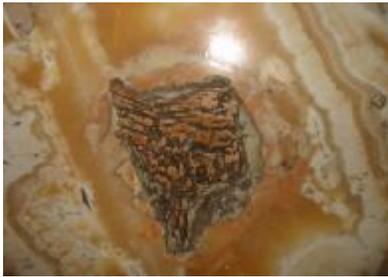
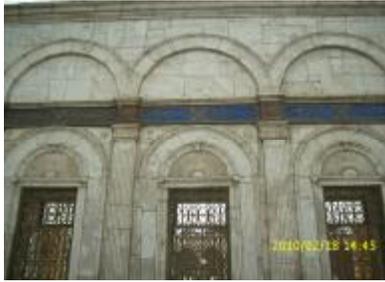
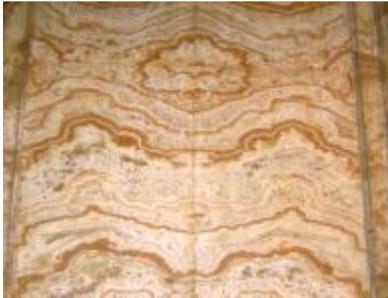
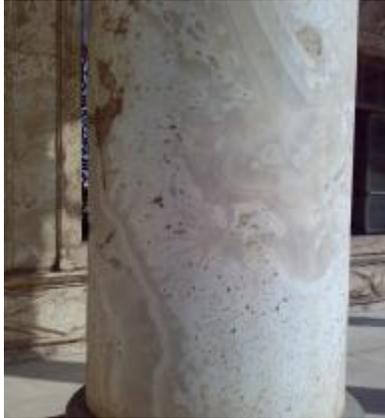
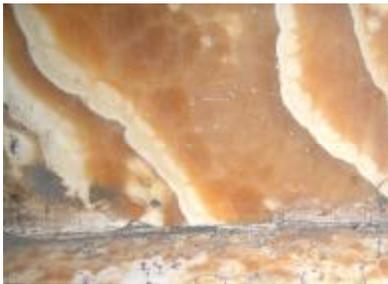
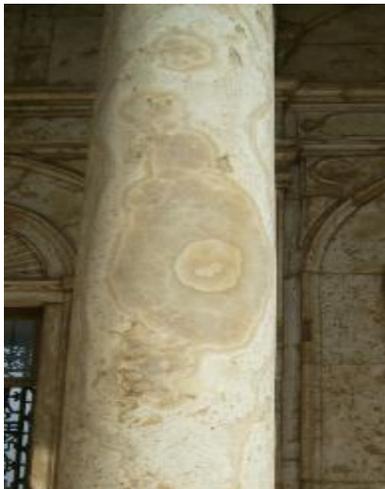
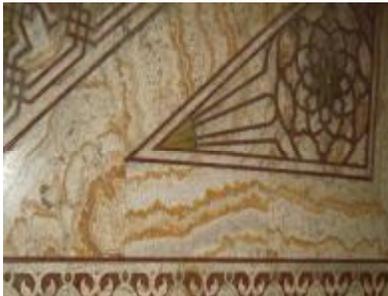
Figs.82-90
 Display the difference between color of the wall-casings of Egyptian alabaster inside (interior veneers) Muhammad Ali Mosque (left column) and outside it (exterior veneers) (left column) is not only noticed but also very obvious and the Bleaching of the latter is visible , Where the coloring of honey , pale-orange , pale yellow , brown or pale tan to yellowish white with an orange tint are bleached or to white color due to exposure to the sun .

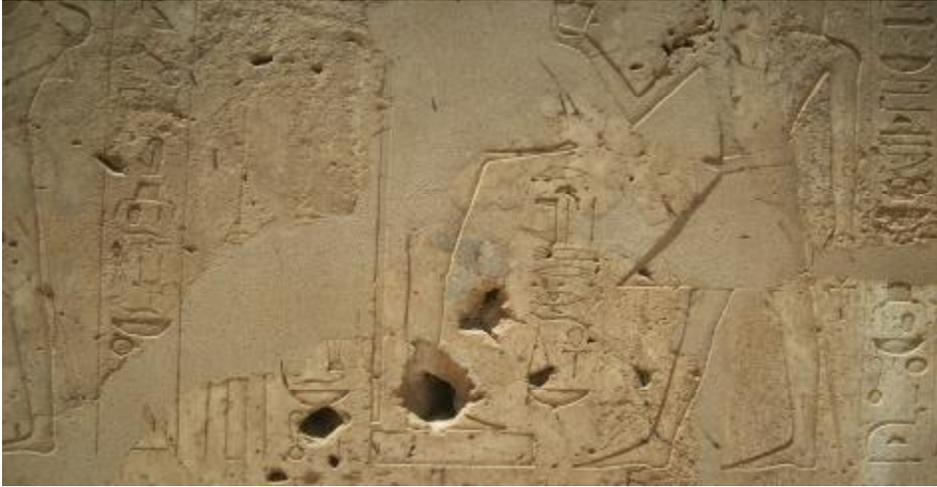
Figs. 91- 95 Display the Bleaching of the exterior surfaces of the chapel of Thutmosis IV at Karnak and other adjacent alabasterite chapels Where the coloring of honey , pale-orange , pale yellow , brown or pale tan to yellowish white with an orange tint are bleached or faded to white color due to exposure to the sun .

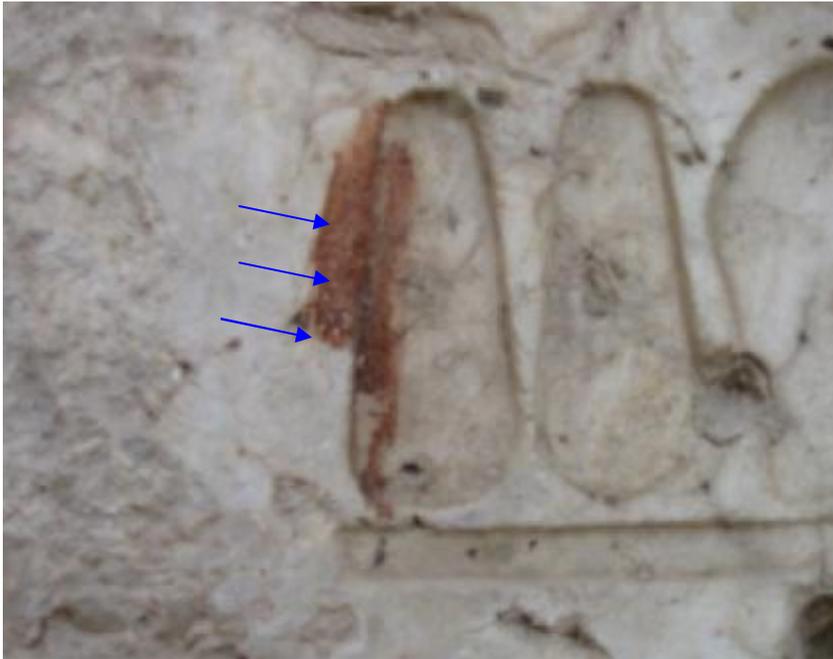
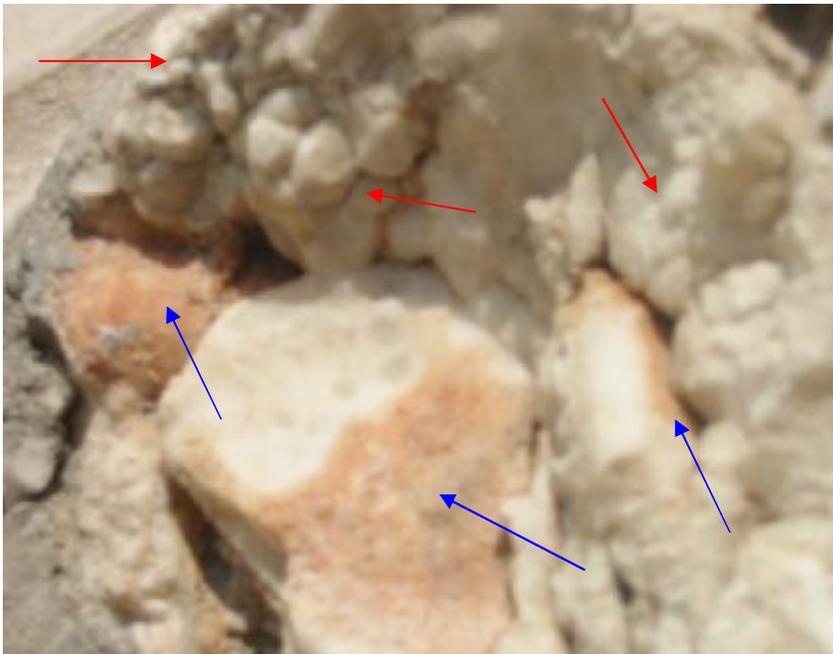
Figs.96-97 Display the iron oxides inside the Egyptian alabaster in both Karnak (left) and Muhammad Ali Mosque veneers(right) (blue arrows) which existed as impurities and which are not responsible the coloration of the Egyptian alabaster, also the granular disintegration into grus can be observed in lower photo (red arrows).

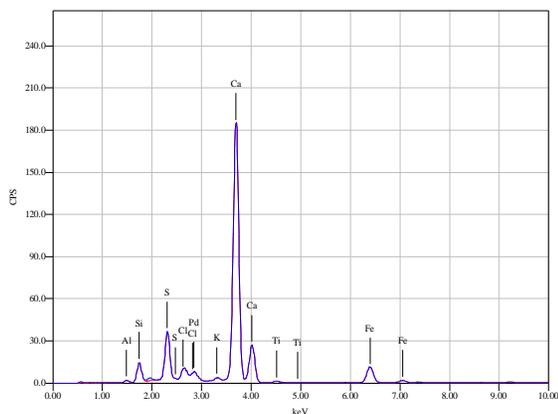
Fig .98 X-ray fluorescence patterns of part of an Egyptian alabaster of exterior wall-casings of Muhammad Ali Mosque , exhibits affluent presence of element sulphur (S) which indicates to the presence and gypsum formation

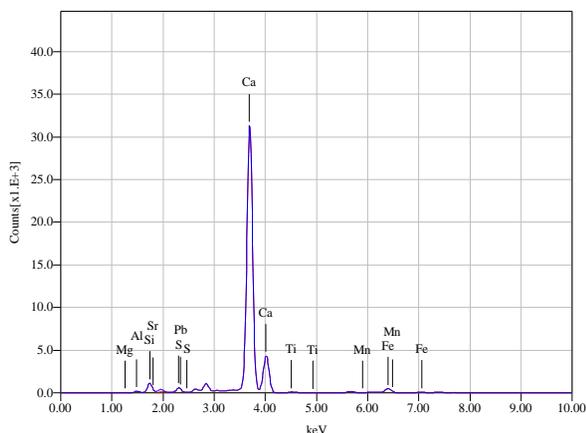
Fig . 99 X-ray fluorescence patterns of part of an Egyptian alabaster of Karnak chapel , exhibits limited presence of element sulphur (S) which indicates to the presence and gypsum formation but less than in Muhammad Ali Mosque , so the presence of some gypsum crystals may be due to Geological formation not to alteration (or degradation) of calcium carbonate to calcium sulphate ., also displays presence of Iron as an impurity .

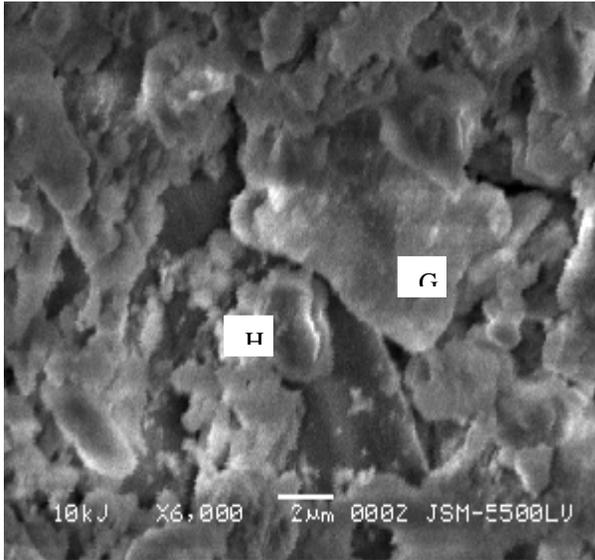
Fig. 100
SEM
micrograph
of the
sample of
exterior
wall-
casings of
Muhammad
Ali Mosque
, exhibits
the
formation
of gypsum
(G), in
addition to
efflorescence

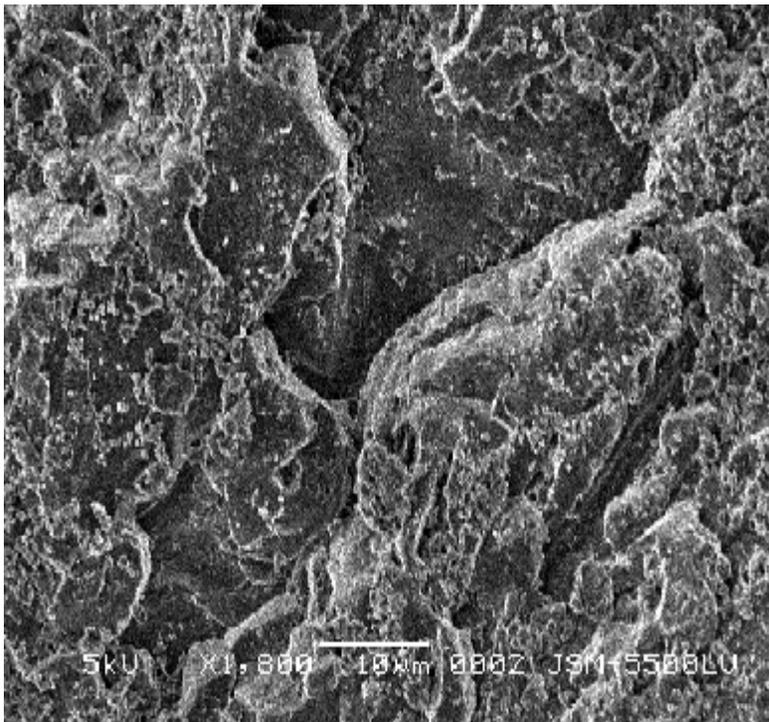
Fig. 101 SEM micrograph of the sample of an Egyptian alabaster of Karnak chapel , exhibits beginning of the formation of gypsum , in addition to efflorescence and sub florescence of Halite (H)

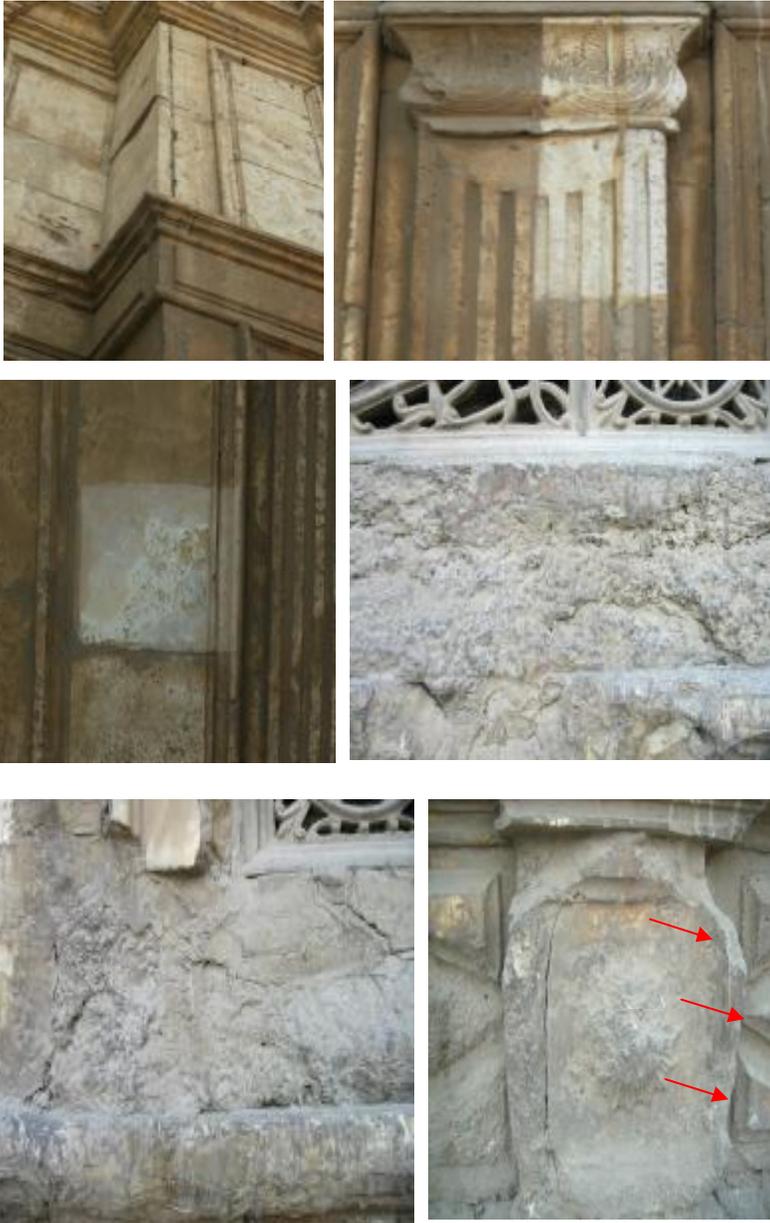
Figs. 102-107 Muhammad Ali Mosque show that the soiling areas easily removed and another type of soiling is not easily removed , also here there is a thick black crusts of irregular shape or discoloration (soiling) to crust are just an extreme case of the lower right photo , Since such crusts are brittle and tend to detach from the alabaster (red arrows) .

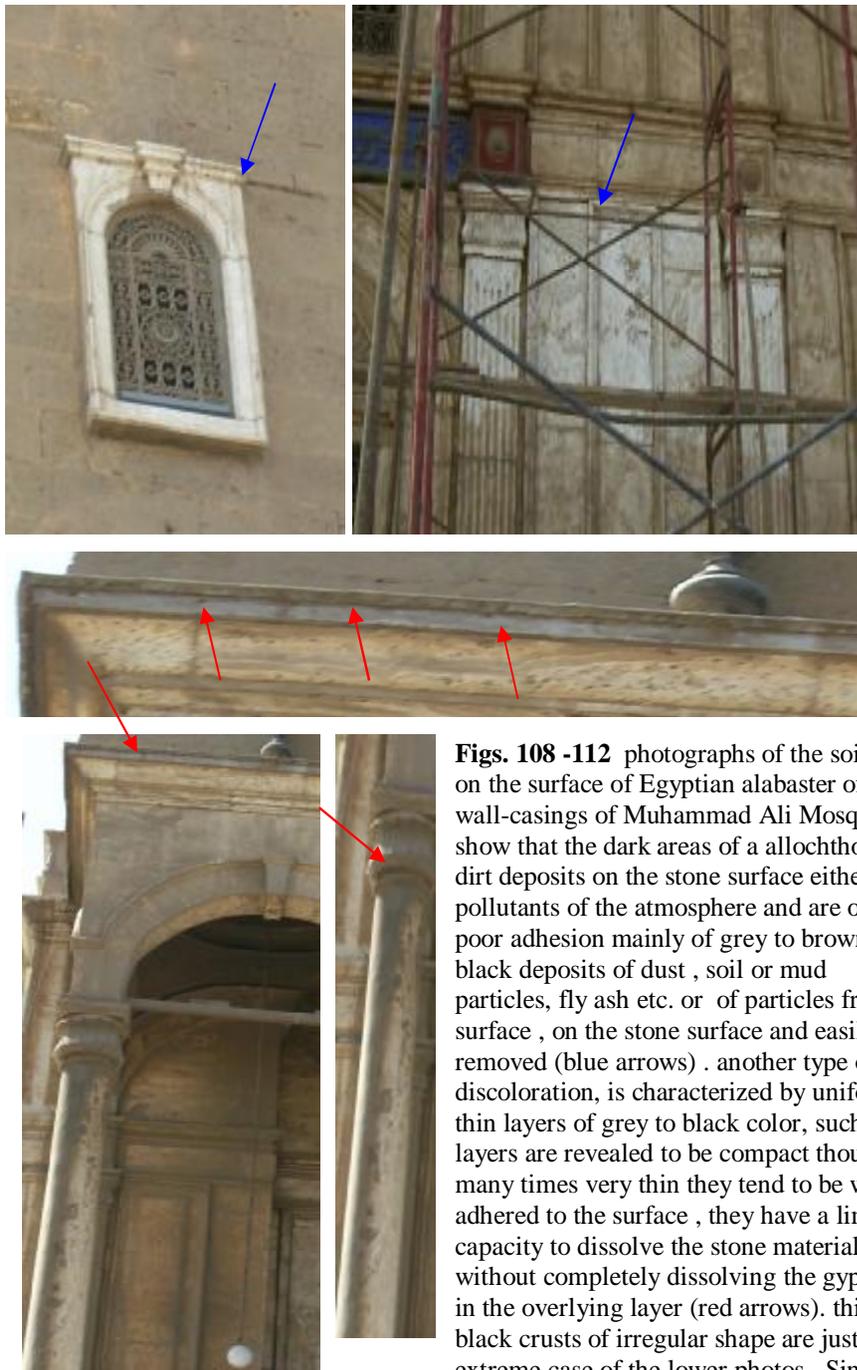
Figs. 108 -112 photographs of the soiling on the surface of Egyptian alabaster of wall-casings of Muhammad Ali Mosque show that the dark areas of a allochthonous dirt deposits on the stone surface either of pollutants of the atmosphere and are of poor adhesion mainly of grey to brown black deposits of dust , soil or mud particles, fly ash etc. or of particles from surface , on the stone surface and easily removed (blue arrows) . another type of discoloration, is characterized by uniform, thin layers of grey to black color, such layers are revealed to be compact though many times very thin they tend to be well-adhered to the surface , they have a limited capacity to dissolve the stone material without completely dissolving the gypsum in the overlying layer (red arrows). thick black crusts of irregular shape are just an extreme case of the lower photos , Since such crusts are brittle and tend to detach from the alabaster .
