Two Examples of Egyptian Alabaster Weathering, Deterioration and Damage from Ancient Egyptian Buildings and Islamic Buildings in Egypt and Some Recommendations of Preservation.

Abdou El-Derby

Abstract:

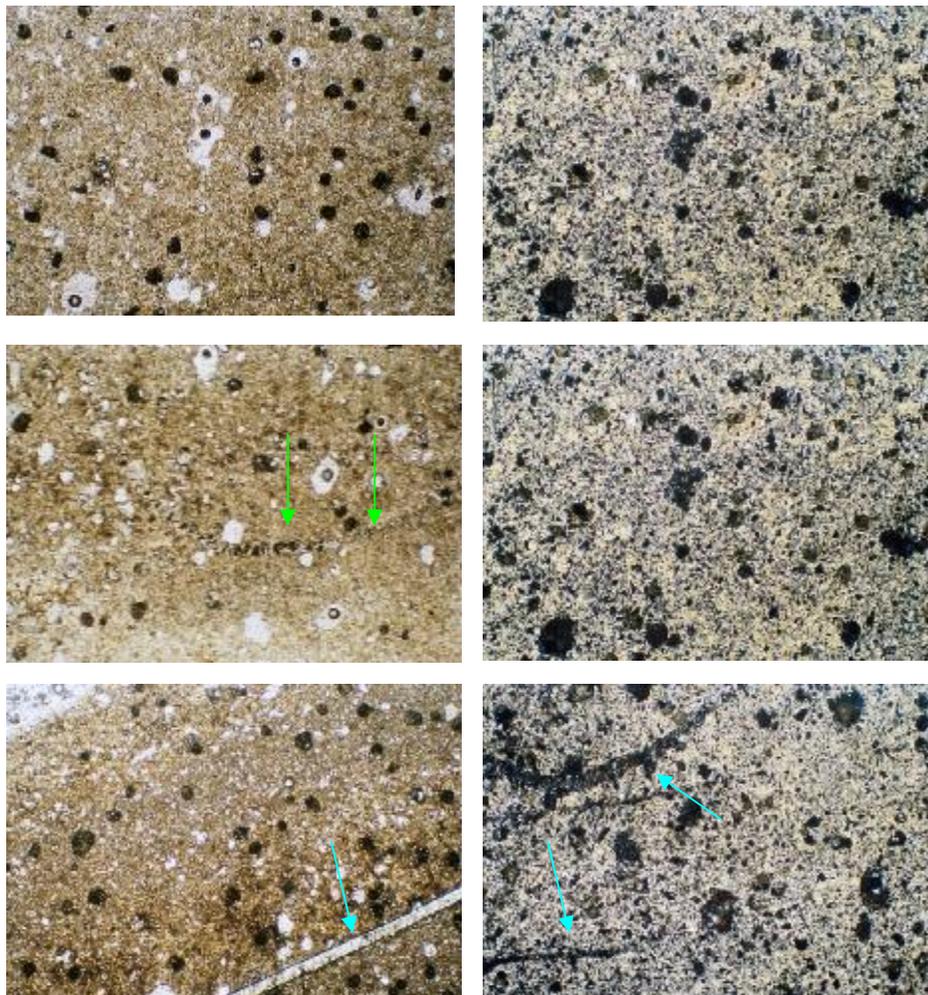
Figs.122 - 127 Thin sections of part of Dark crust on the surface of a part of an Egyptian alabaster of Muhammad Ali Mosque cross sections (normal) (left column) (cross Nicol) (right column) x 4 display the presence of gypsum crystals (of white color in left column and of black color in right column) which distributed not only to the surface layer but also distributed inwards and also in pores , the size of gypsum crystals gradually increases outward from the substrate within this layer exterior part of the crust, where the crystals are free to grow, also display minute vugs(of black color in left column) , also display micro cracks (turquoise arrows) ,and a developing micro cracks (bright green arrows) , The underlying substrate is cemented with carbonate and forms a thin weathering rim on the alabaster which is encrusted by gypsum-rich outer layer .

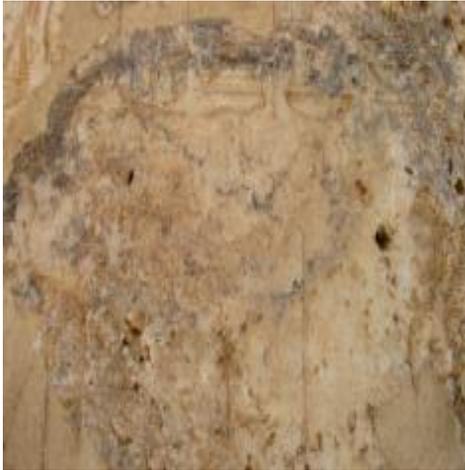
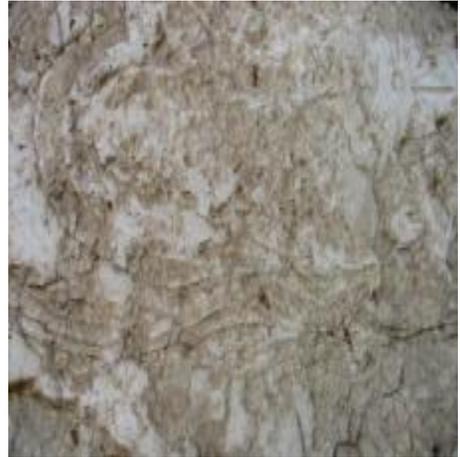
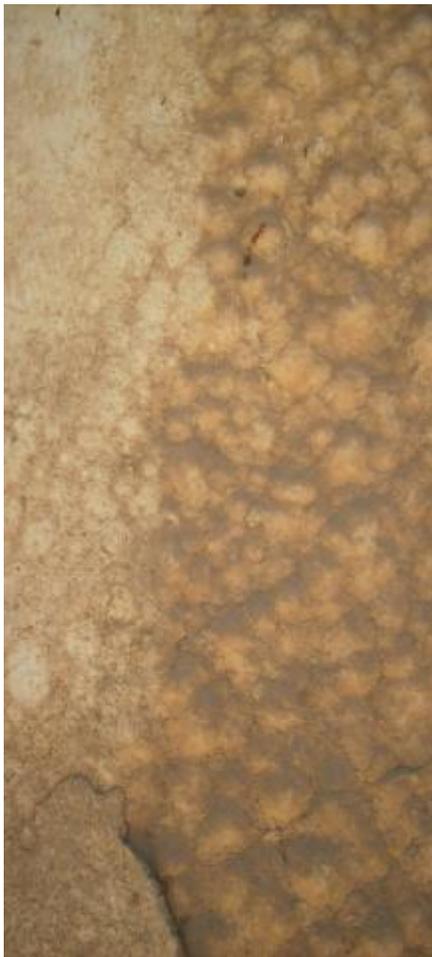
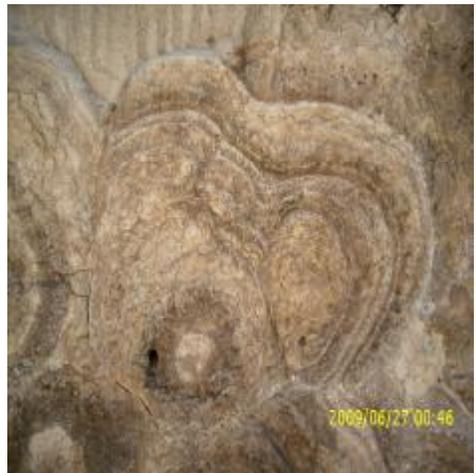
Figs.128 -131 display the travertine of chapels at Karnak of Wadi El-Assiuty, where show symptoms of Efflorescence Sub florescence of Halite salt, we can observe in the lower left photo. The form light - colored crust of salt tracing the surface where compact deposit, light - colored, changing the morphology of alabaster surface , due to mainly precipitation process .

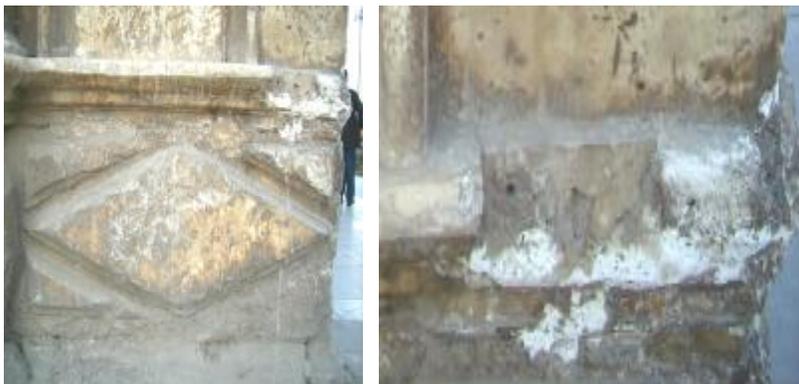
Figs.134-135 display Egyptian alabaster of the southern east façade of Muhammad Ali Mosque displays, where display

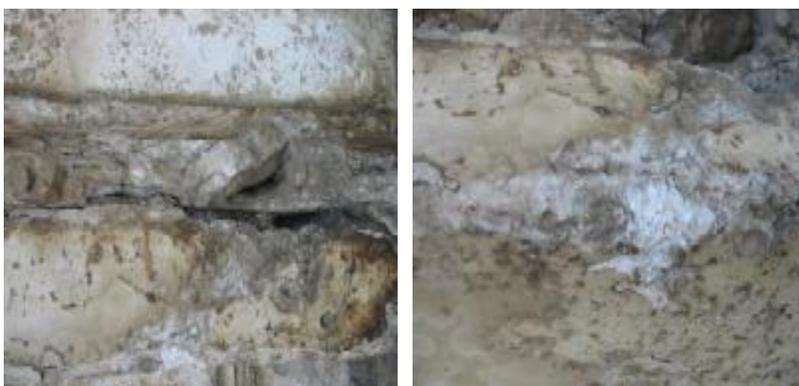
Figs.139-140 display Egyptian alabaster of the façade of Muhammad Ali Mosque displays, where display symptoms of Efflorescence Sub florescence of Halite salt

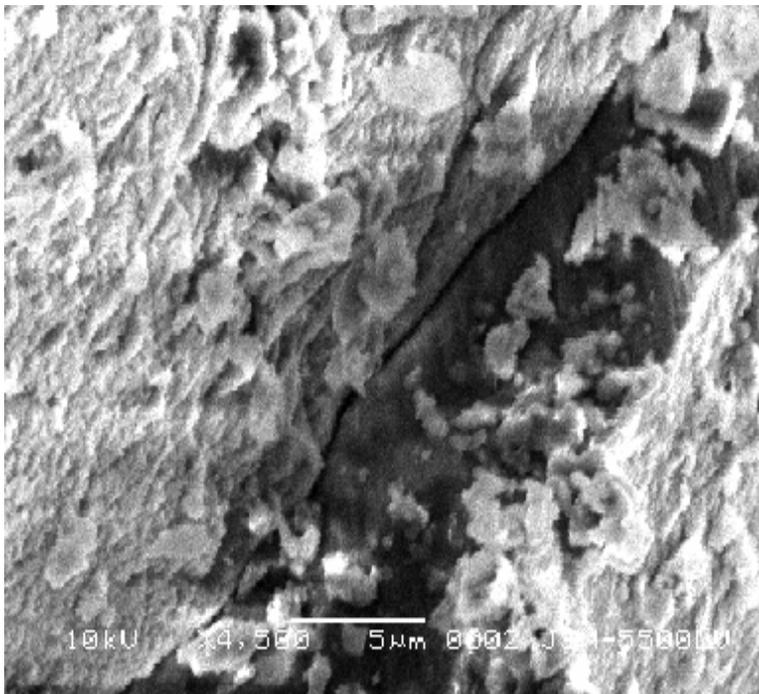
Fig.142 SEM micrograph of the sample of an Egyptian alabaster of Muhammad Ali Mosque displays efflorescence and sub fluorescence of Halite, in addition to beginning of the formation of gypsum.

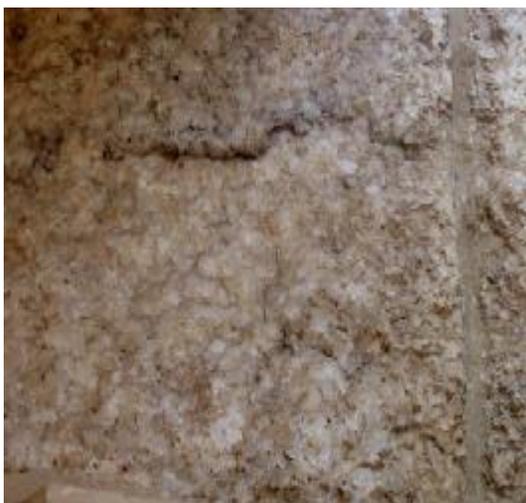
Fig. 143 lay the roughening in the travertine of chapels at Karnak as a finest relief resp. alteration of gloss due to the loss smallest stone particles or corrosion of stone surface smoothed by sawing , grinding or polishing , it is observed on the surfaces of the travertine of chapels at Karnak .

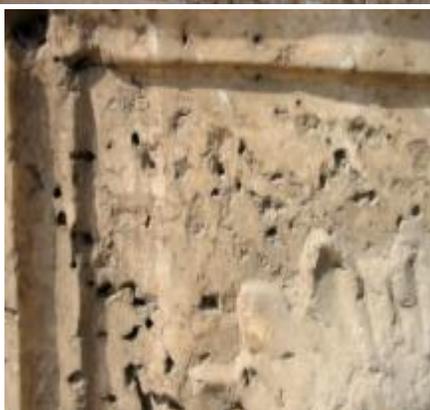
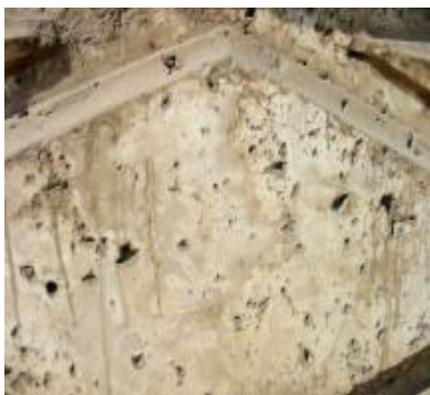
Figs.144-147 Display the form of small pits - are caused by biogenically induced corrosion processes, particularly in carbonate rocks , it is noticed only on the Egyptian alabaster surfaces of Muhammad Ali Mosque , it is not noticed on the surfaces of chapels at Karnak

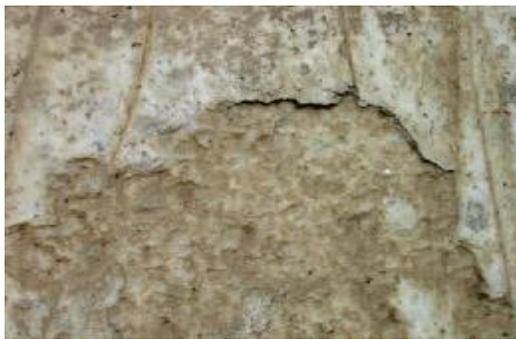
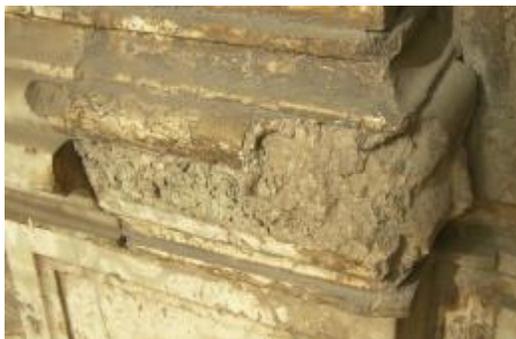
Figs. 148-149 Display Back weathering due to loss of scales where is observed in Egyptian alabaster surfaces of both chapels at Karnak (above) Muhammad

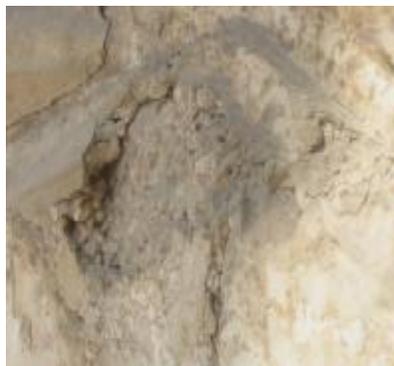
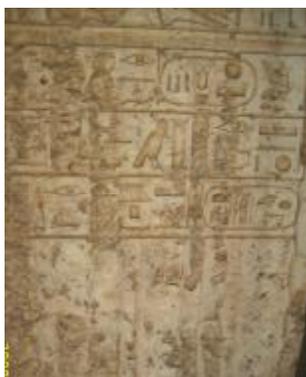
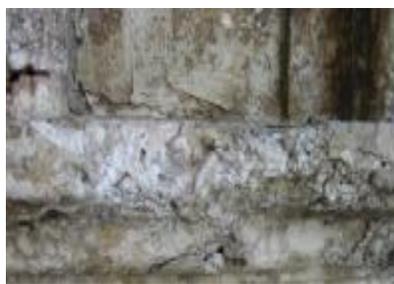
Figs.150 -153 Display the granular disintegration which is Detachment of individual grains or small grain aggregate into grus where there is detachment of larger grains as individual grains or small grain aggregates (stone grus), in Egyptian alabaster of both

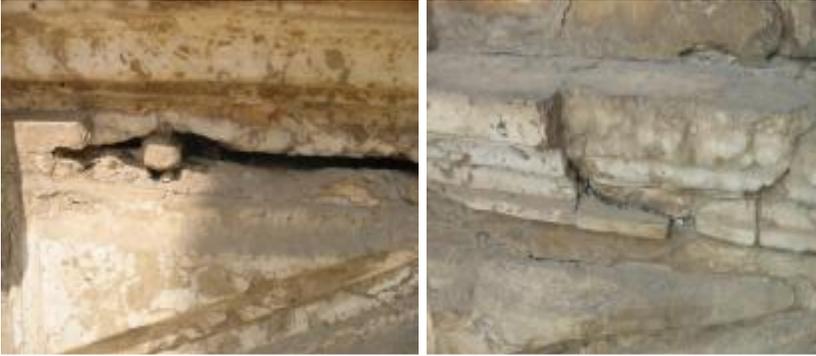
Figs. 154- 155 Display the crumbling which is Detachment of larger , compact stone elements in the form of crumbs, in Egyptian alabaster of Muhammad Ali Mosque and not observed in chapels at Karnak.

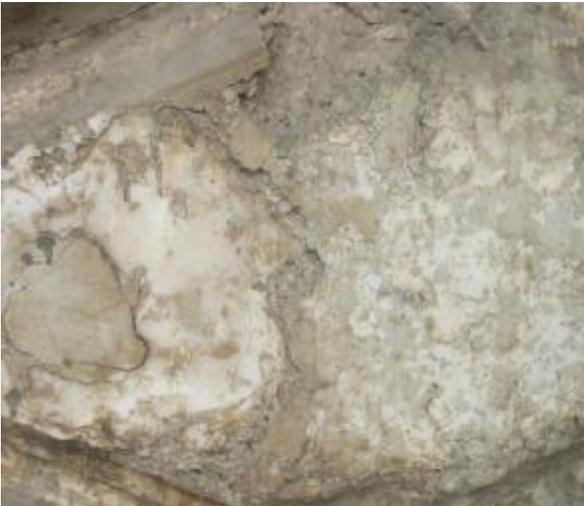
Fig.156
Display flaking to contour scaling, in Egyptian alabaster of Muhammad Ali Mosque and not observed in chapels at Karnak.

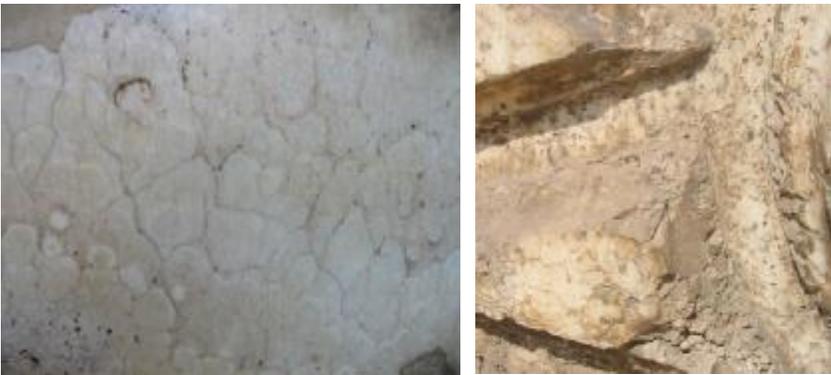
Fig.157-158 Display fissures independent of stone structure in Egyptian alabaster of both chapels at Karnak (left) and Muhammad Ali Mosque (right).

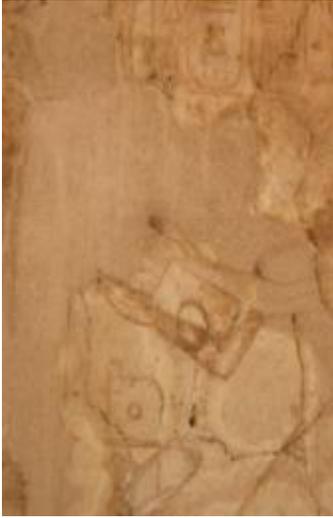
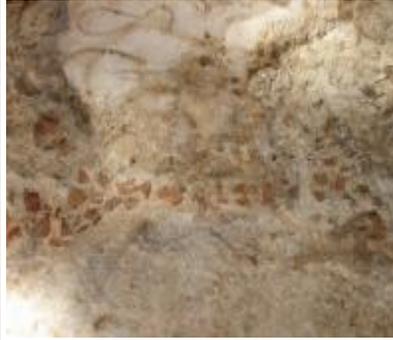
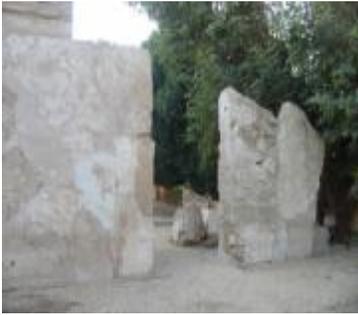
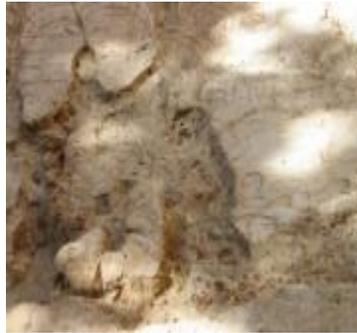
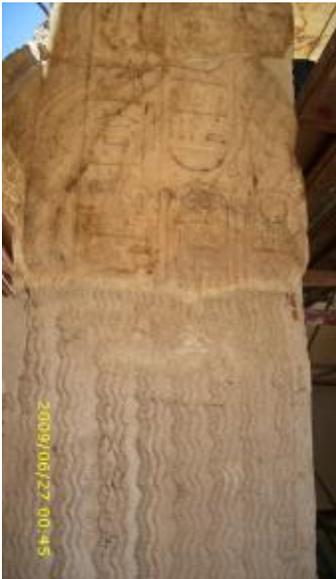
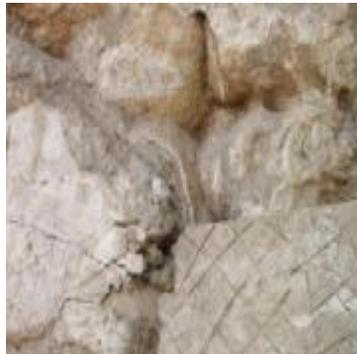
Figs.159-164

Display some Man-made faults (erroneous restoration)

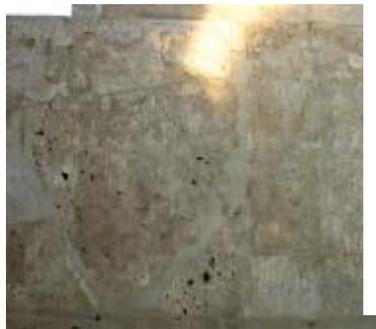
In the chapels of Karnak – where the blocks of the chapels of Thutmosis IV Senwosert I , Amenhotpe I and Hatshepsut were reused in core of Pylon No. III at Karnak – were reconstructed and were compensated with unsuitable material (Portland and white cement) and in with out character style .

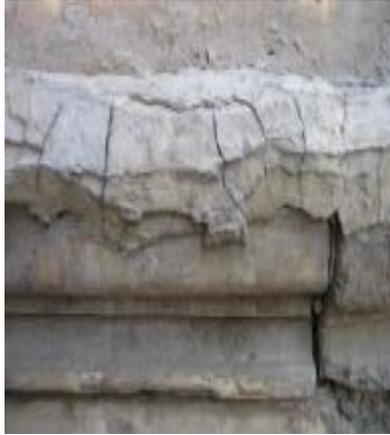
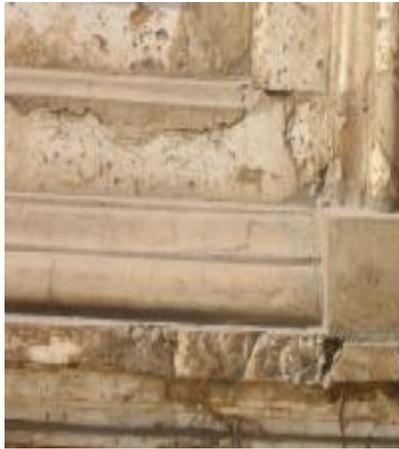
Figs.165- 167 display some Man-made faults (erroneous restoration) in Muhammad Ali Mosque alabaster veneers were compensated with unsuitable material (Portland and white cement) and in with out character style .
