## **Gilding technique in Islamic monumental decorated ceilings in Cairo: analytical study.**

**Atef A. Brania**

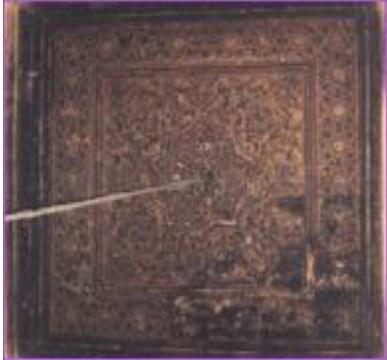
<p>Fig. 7 Photographs (macro and micro) corresponding to the gilded ceiling of Madrasa of El-Zaher Brqoq shows its status.</p>	<p>Fig. 8 Photograph corresponding to the gilded ceiling of Madrasa of El-Kady Abd El-Baset shows its dramatic status as a all.</p>

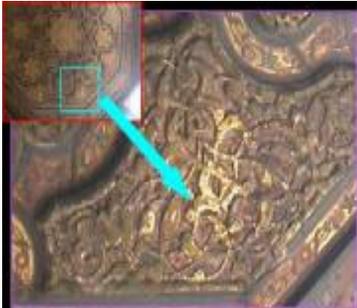
<p>Fig. 9 Photographs (macro and micro) corresponding to the gilded ceiling of El-Kady Yehia Zein El-Dine shows its dramatic status.</p>	<p>Fig. 10 Photographs (macro and micro) corresponding to the gilded ceiling of Mosque of Moheb El- Dine Abo El-tayb shows its dramatic status.</p>

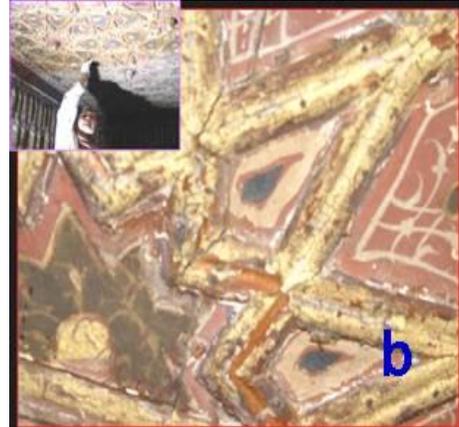
Fig. 11 a,b Photographs (macro and micro) corresponding to the gilded ceiling of El-Sadat house shows its status.( Notice the gilding craquelure).
